# Access Compliance Report

## Public Rights-of-Way

### (Curb Ramps)

| Intersection ID: 13889 | Main Street: DENVIEW_LN | Cross Street: KENHILL_DR | Location: SW |

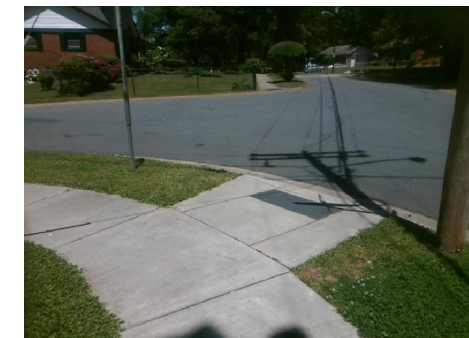
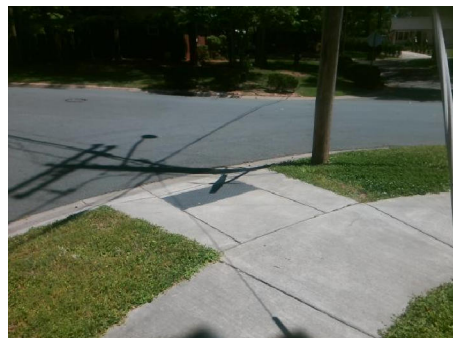
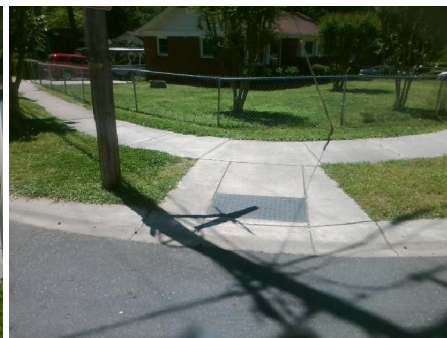
| Compliance | Description | Data | Compliance | Description | Data |
|---|---|---|---|---|---|
| N/A | Ramp Length (in) | 74.0 | No | Ramp Slope (%) | 8.6 |
| No | Ramp Width (in) | 46.0 | Yes | Ramp XSlope (%) | 0.2 |

**Remove & Replace Curb Ramp With Two New Directional Ramps or Equivalent.**
