# Access Compliance Report

## Public Rights-of-Way

| Intersection ID: 15457 | Main Street: EAST_BV | Cross Street: LOMBARDY_CR | Location: W |
| ADA ID: CF133F1EC469 | Ramp Type: Perp | Initial Pass/Fail: Fail | Overall Compliance: No |

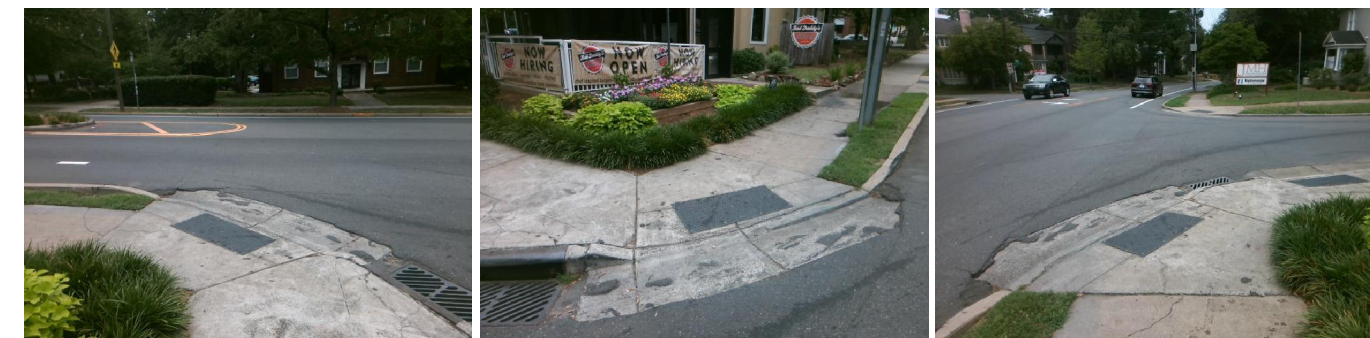
**Not Found, R304.2.2, R304.5.3**

| Compliance | Description | Data | Compliance | Description | Data |
|---|---|---|---|---|---|
| N/A | Ramp Length (in) | 59.0 | No | Ramp Slope (%) | 10.3 |
| Yes | Ramp Width (in) | 48.0 | No | Ramp XSlope (%) | 6.3 |

**Remove & Replace Entire Ramp.**
