Access Compliance Report

Public Rights-of-Way

(Curb Ramps)

Intersection ID: 14341	Main Street: BAY_ST	Cross Street: LORNA_ST	Location: S
ADA ID: D0CAFC96C7D4	Ramp Type: Perp	Initial Pass/Fail: Fail	Overall Compliance: No
Severity Score: 12.5			
Codes/Mitigation Info/Possible Solution		Field Measurements/Component Compliance

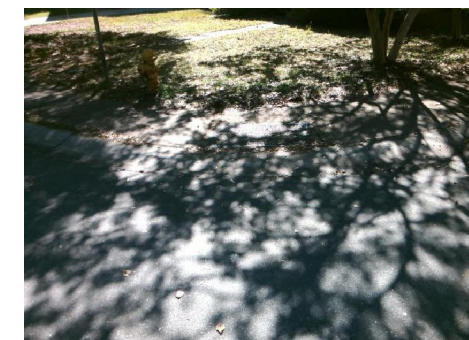
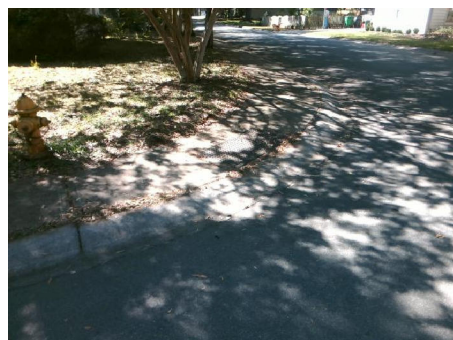
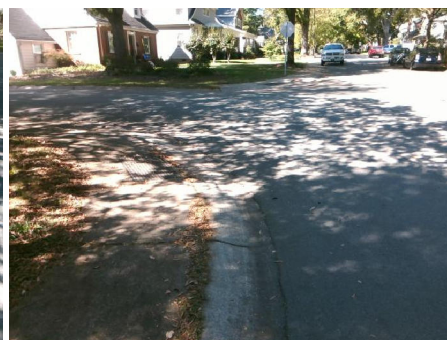
Not Found, R304.5.3

Compliance	Description	Data	Compliance	Description	Data
N/A	Ramp Length (in)	60.0	Yes	Ramp Slope (%)	5.7
Yes	Ramp Width (in)	48.0	No	Ramp XSlope (%)	5.2
N/A	Flare Type LT	N/A	N/A	Flare Type RT	N/A
N/A	Flare Slope LT (%)	N/A	N/A	Flare Slope RT (%)	N/A
N/A	Flare Traversable LT?	N/A	N/A	Flare Traversable RT?	N/A
N/A	Landing Length (in)	N/A	N/A	DWS Provided?	N/A
N/A	Landing Width (in)	N/A	N/A	DWS Contrast?	N/A
N/A	Landing Slope (%)	N/A	N/A	DWS Length (in)	N/A
N/A	Landing X Slope (%)	N/A	N/A	DWS Full Width?	N/A
N/A	Landing Curb? (Y/N)	N/A	N/A	DWS Offset (in)	N/A
N/A	Shared Landing?	N/A			
N/A	Gutter Ponding?	N/A	N/A	Gutter Slope (%)	N/A
N/A	Gutter Lip Ht (in)	N/A	N/A	Gutter X Slope (%)	N/A
N/A	Painted X Walk1?	No	N/A	Painted X Walk2?	N/A
	X Walk 1 Direction	To NW		X Walk 2 Direction	N/A
N/A	X Walk 1 Width (in)	N/A	N/A	X Walk 2 Width (in)	N/A
	X Walk 1 Slope (%)	3.7		X Walk 2 Slope (%)	N/A
	X Walk 1 X Slope (%)	0.6		X Walk 2 X Slope (%)	N/A

N/A	Ramp inside XWalk1?	N/A	N/A	Ramp inside XWalk2?	N/A
	Road Slope (%)	N/A	N/A	Clear Space?	N/A
	Road X Slope (%)	N/A	N/A	Clear Space to XWalk (in)	N/A
N/A	Any Obstructions?	N/A	N/A	Storm Grate/Utility Hazard?	N/A
	Obstruction Type			Storm Grate/Utility Type	
		N/A			N/A
		Yes		Surface Condition? (G/P)	Good

Possible Solutions:

Remove & Replace Entire Ramp.
