Access Compliance Report

Public Rights-of-Way

(Curb Ramps)

Intersection ID: 2671	Main Street: ELBERON_CT	Cross Street: MCCHESENEY_DR	Location:	N
ADA ID: D117E33CD356	Ramp Type: Combination1	Initial Pass/Fail: Fail	Overall Compliance: No	Severity Score: 46.25
Codes/Mitigation Info/Possible Solution		Field Measurements/Component Compliance

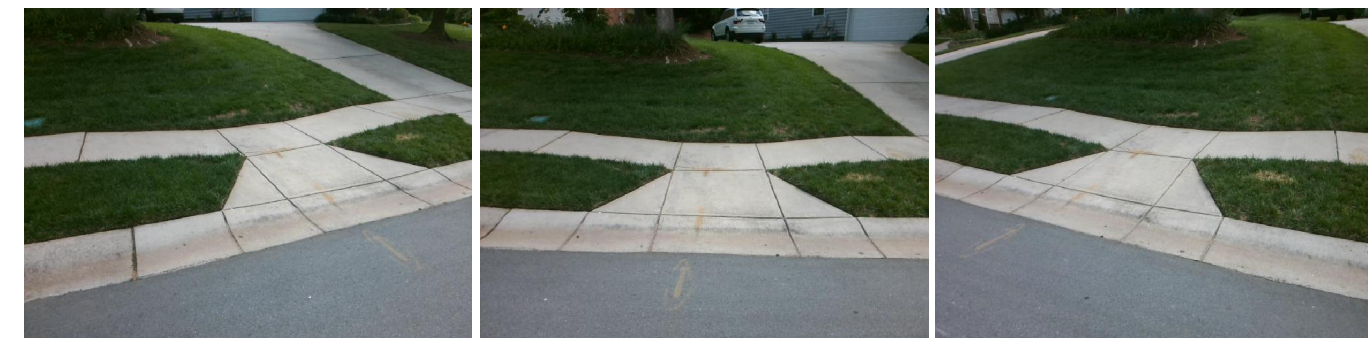
**R304.5.1, R304.5.1, R304.2.2,
R304.5.3, R304.3.2**

Compliance	Description	Data	Compliance	Description	Data
N/A	Ramp Length LT (in)	69.5	N/A	Ramp Length RT (in)	60.0
Yes	Ramp Width LT (in)	48.0	No	Ramp Width RT (in)	47.0
No	Ramp Slope LT (%)	9.6	Yes	Ramp Slope RT (%)	7.9
No	Ramp XSlope LT (%)	4.6	No	Ramp XSlope RT (%)	3.8
N/A	Ramp Length (in)	45.0	No	Ramp Slope (%)	9.1
No	Ramp Width (in)	46.0	No	Ramp XSlope (%)	12.0
N/A	Flare Type LT	N/A	N/A	Flare Type RT	N/A
N/A	Flare Slope LT (%)	N/A	N/A	Flare Slope RT (%)	N/A
N/A	Flare Traversable LT?	N/A	N/A	Flare Traversable RT?	N/A
N/A	Landing Length (in)	N/A	N/A	DWS Provided?	N/A
N/A	Landing Width (in)	N/A	N/A	DWS Contrast?	N/A
N/A	Landing Slope (%)	N/A	N/A	DWS Length (in)	N/A
N/A	Landing X Slope (%)	N/A	N/A	DWS Full Width?	N/A
N/A	Landing Curb? (Y/N)	N/A	N/A	DWS Offset (in)	N/A
N/A	Shared Landing?	N/A			
N/A	Gutter Ponding?	N/A	N/A	Gutter Slope (%)	N/A
N/A	Gutter Lip Ht (in)	N/A	N/A	Gutter X Slope (%)	N/A
N/A	Painted X Walk1?	No	N/A	Painted X Walk2?	N/A

X Walk 1 Direction	To SW		X Walk 2 Direction	N/A
	X Walk 1 Width (in)	N/A		X Walk 2 Width (in)	N/A
	X Walk 1 Slope (%)	2.9		X Walk 2 Slope (%)	N/A
	X Walk 1 X Slope (%)	1.1		X Walk 2 X Slope (%)	N/A
N/A	Ramp inside XWalk1?	N/A	N/A	Ramp inside XWalk2?	N/A
	Road Slope (%)	N/A		Clear Space?	N/A
	Road X Slope (%)	N/A	N/A	Clear Space to XWalk (in)	N/A
			N/A	Any Obstruction?	N/A
				Obstruction Type	N/A
			N/A	Storm Grate/Utility Hazard?	N/A
				Storm Grate/Utility Type	N/A
			Yes	Surface Condition? (G/P)	Good
				Curb Slope (%)	N/A

Remove & Replace Entire Ramp.
