Access Compliance Report

Public Rights-of-Way

(Curb Ramps)

Intersection ID: 26390	Main Street: BAYBROOK_LN	Cross Street: BEVINGTON_PL	Location: NE
ADA ID: D46E8D6B8A16	Ramp Type: PerpDiag	Initial Pass/Fail: Fail	Overall Compliance: No
Severity Score: 8.75			
Codes/Mitigation Info/Possible Solution		Field Measurements/Component Compliance

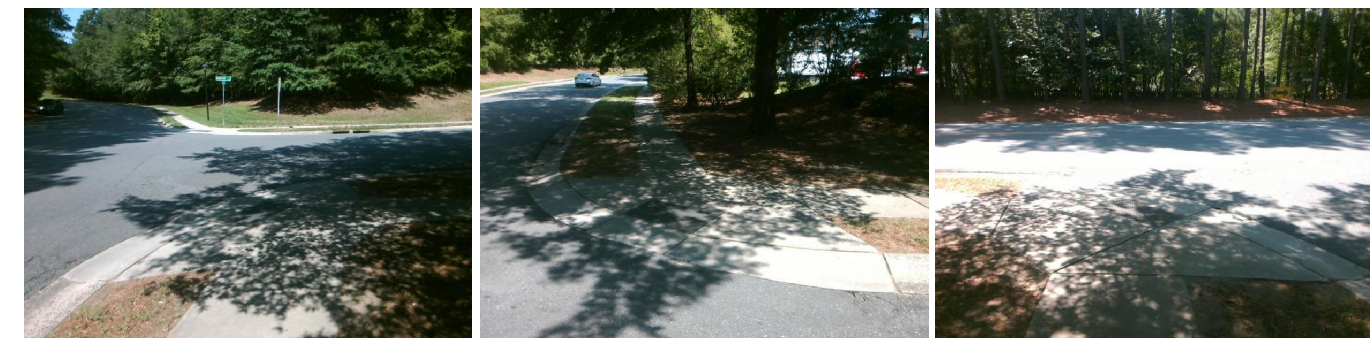
Not Found, R304.5.1

Compliance	Description	Data	Compliance	Description	Data
N/A	Ramp Length (in)	84.0	Yes	Ramp Slope (%)	8.3
No	Ramp Width (in)	47.0	Yes	Ramp XSlope (%)	1.0
N/A	Flare Type LT	N/A	N/A	Flare Type RT	N/A
N/A	Flare Slope LT (%)	N/A	N/A	Flare Slope RT (%)	N/A
N/A	Flare Traversable LT?	N/A	N/A	Flare Traversable RT?	N/A
N/A	Landing Length (in)	N/A	N/A	DWS Provided?	N/A
N/A	Landing Width (in)	N/A	N/A	DWS Contrast?	N/A
N/A	Landing Slope (%)	N/A	N/A	DWS Length (in)	N/A
N/A	Landing X Slope (%)	N/A	N/A	DWS Full Width?	N/A
N/A	Landing Curb? (Y/N)	N/A	N/A	DWS Offset (in)	N/A
N/A	Shared Landing?	N/A			
N/A	Gutter Ponding?	N/A	N/A	Gutter Slope (%)	N/A
N/A	Gutter Lip Ht (in)	N/A	N/A	Gutter X Slope (%)	N/A
N/A	Painted X Walk1?	No	N/A	Painted X Walk2?	No
	X Walk 1 Direction	To SW		X Walk 2 Direction	To S
N/A	X Walk 1 Width (in)	N/A	N/A	X Walk 2 Width (in)	N/A
	X Walk 1 Slope (%)	3.4		X Walk 2 Slope (%)	2.6
	X Walk 1 X Slope (%)	0.4		X Walk 2 X Slope (%)	0.4

N/A	Ramp inside XWalk1?	N/A	N/A	Ramp inside XWalk2?	N/A
	Road Slope (%)	1.5	N/A	Clear Space?	N/A
	Road X Slope (%)	1.1	N/A	Clear Space to XWalk (in)	N/A
N/A	Any Obstructions?	N/A	N/A	Storm Grate/Utility Hazard?	N/A
	Obstruction Type			Storm Grate/Utility Type	
		N/A			N/A
			Yes	Surface Condition? (G/P)	Good

Remove & Replace Curb Ramp With Two New Directional Ramps or Equivalent.
