Access Compliance Report

Public Rights-of-Way

(Curb Ramps)

Intersection ID: 3853	Main Street: CADENCIA_CT	Cross Street: GLASTON_LN	Location: W
ADA ID: D4D8EC0B08BF	Ramp Type: Directional1	Initial Pass/Fail: Fail	Overall Compliance: No
Severity Score: 13.75			
Codes/Mitigation Info/Possible Solution		Field Measurements/Component Compliance

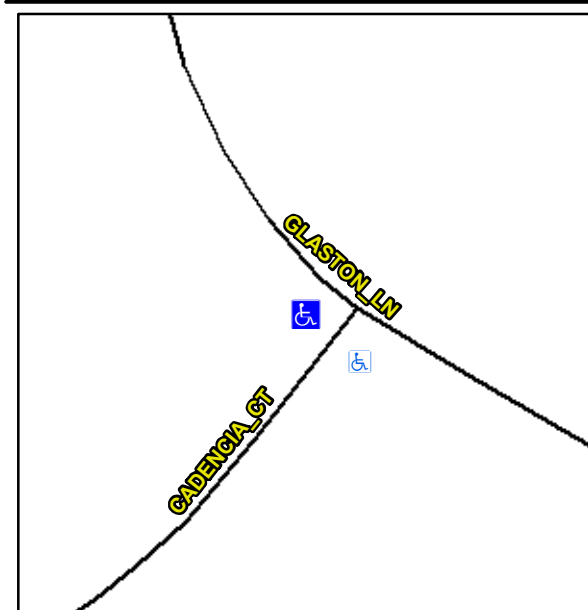
R304.2.2, R304.5.3

Compliance	Description	Data	Compliance	Description	Data
N/A	Ramp Length (in)	66.0	N/A	Grade Break?	N/A
Yes	Ramp Width (in)	50.0	N/A	Grade Break Slope (%)	0.0
No	Ramp Slope (%)	9.9	N/A	Grade Break XSlope (%)	0.0
No	Ramp XSlope (%)	2.9			
N/A	Flare Type LT	N/A	N/A	Flare Type RT	N/A
N/A	Flare Slope LT (%)	N/A	N/A	Flare Slope RT (%)	0.0
N/A	Flare Traversable LT?	N/A	N/A	Flare Traversable RT?	N/A
N/A	Landing Length (in)	0.0	N/A	DWS Provided?	N/A
N/A	Landing Width (in)	0.0	N/A	DWS Contrast?	N/A
N/A	Landing Slope (%)	0.0	N/A	DWS Length (in)	N/A
N/A	Landing X Slope (%)	0.0	N/A	DWS Full Width?	N/A
N/A	Landing Curb? (Y/N)	N/A	N/A	DWS Offset LT (in)	N/A
N/A	Shared Landing?	N/A	N/A	DWS Offset RT (in)	N/A
N/A	Gutter Ponding?	0.0	N/A	Gutter Slope (%)	N/A
N/A	Gutter Lip Ht (in)	0.0	N/A	Gutter X Slope (%)	N/A
N/A	Painted X Walk1?	No		Road Slope (%)	2.8
	X Walk 1 Direction	To SE		Road X Slope (%)	5.2
	X Walk 1 Width (in)	N/A		Clear Space?	N/A

X Walk 1 Slope (%)	2.8	N/A	Clear Space to XWalk (in)	N/A
	X Walk 1 X Slope (%)	5.2	N/A	Storm Grate/Utility Hazard?	N/A
N/A	Ramp inside XWalk1?	N/A		Storm Grate/Utility Type	
N/A	Any Obstructions?	N/A			N/A
	Obstruction Type		Yes	Surface Condition? (G/P)	Good
			N/A	Curb Slope (%)	N/A

Remove & Replace Entire Ramp.
