Access Compliance Report Public Rights-of-Way (Curb Ramps)

Intersection ID: N/A	Main Street: N_TRYON_ST	Cross Street: W_29TH_ST	Location: NW
ADA ID: D5A0C42382E8	Ramp Type: Combination1Diag	Initial Pass/Fail: Fail	Overall Compliance: No Severity Score: 0

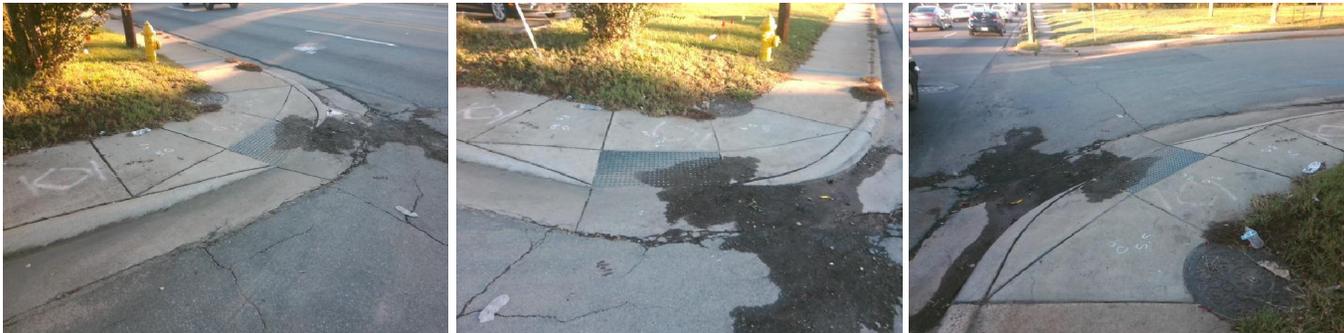
PROW/ADA:
Not Found, R304.2.2, R304.5.3

Compliance	Description	Data	Compliance	Description	Data
N/A	Ramp Length LT (in)	32.0	N/A	Ramp Length RT (in)	31.0
Yes	Ramp Width LT (in)	60.5	Yes	Ramp Width RT (in)	51.0
Yes	Ramp Slope LT (%)	8.0	Yes	Ramp Slope RT (%)	5.5
No	Ramp XSlope LT (%)	6.3	Yes	Ramp XSlope RT (%)	0.0
N/A	Ramp Length (in)	25.0	No	Ramp Slope (%)	9.6
Yes	Ramp Width (in)	48.0	No	Ramp XSlope (%)	3.0
N/A	Flare Type LT	N/A	N/A	Flare Type RT	N/A
N/A	Flare Slope LT (%)	N/A	N/A	Flare Slope RT (%)	N/A
N/A	Flare Traversable LT?	N/A	N/A	Flare Traversable RT?	N/A
N/A	Landing Length (in)	N/A	N/A	DWS Provided?	N/A
N/A	Landing Width (in)	N/A	N/A	DWS Contrast?	N/A
N/A	Landing Slope (%)	N/A	N/A	DWS Length (in)	N/A
N/A	Landing X Slope (%)	N/A	N/A	DWS Full Width?	N/A
N/A	Landing Curb? (Y/N)	N/A	N/A	DWS Offset (in)	N/A
N/A	Shared Landing?	N/A			
N/A	Gutter Ponding?	N/A	N/A	Gutter Slope (%)	N/A
N/A	Gutter Lip Ht (in)	N/A	N/A	Gutter X Slope (%)	N/A
N/A	Painted X Walk1?	No	N/A	Painted X Walk2?	No

X Walk 1 Direction	To SW		X Walk 2 Direction	To SE
	X Walk 1 Width (in)	N/A		X Walk 2 Width (in)	N/A
	X Walk 1 Slope (%)	5.0		X Walk 2 Slope (%)	4.7
	X Walk 1 X Slope (%)	4.1		X Walk 2 X Slope (%)	1.4
N/A	Ramp inside XWalk1?	N/A	N/A	Ramp inside XWalk2?	N/A
	Road Slope (%)	3.2		Clear Space?	N/A
	Road X Slope (%)	4.6	N/A	Clear Space to XWalk (in)	N/A
			N/A	Any Obstruction?	N/A
				Obstruction Type	
					N/A
			N/A	Storm Grate/Utility Hazard?	N/A
				Storm Grate/Utility Type	
					N/A
Yes	Surface Condition? (G/P)				Good
	Curb Slope (%)				8.5

Possible Solutions:
Remove & Replace Curb Ramp With Two New Directional Ramps or Equivalent.
