Access Compliance Report

Public Rights-of-Way

(Curb Ramps)

Intersection ID: 45173	Main Street: LINDEN_TREE_LN	Cross Street: MAPLEHURST_DR	Location: SE
ADA ID: D7592EF6992F	Ramp Type: PerpDiag	Initial Pass/Fail: Fail	Overall Compliance: No
		Severity Score: 22.5

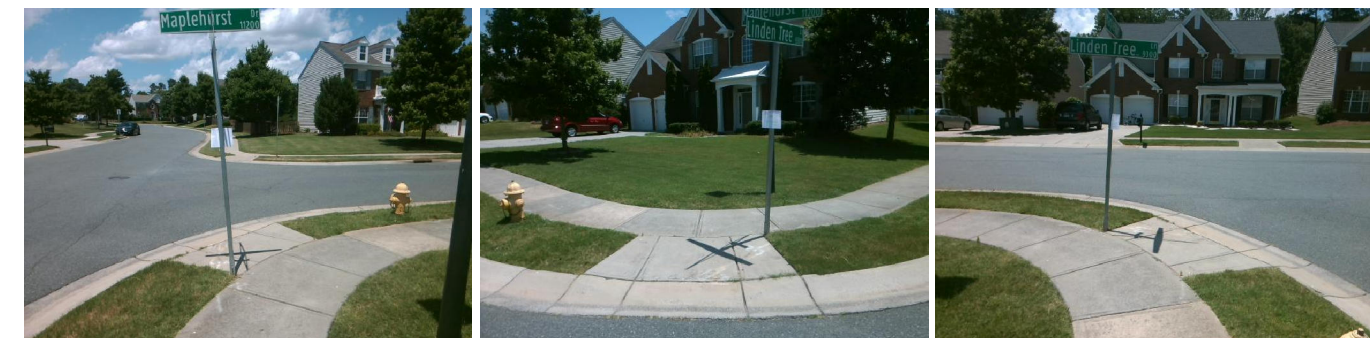
Not Found, R304.5.1, R304.2.2, R304.5.3

Compliance	Description	Data	Compliance	Description	Data
N/A	Ramp Length (in)	42.0	No	Ramp Slope (%)	9.5
No	Ramp Width (in)	41.0	No	Ramp XSlope (%)	3.5
N/A	Flare Type LT	N/A	N/A	Flare Type RT	N/A
N/A	Flare Slope LT (%)	N/A	N/A	Flare Slope RT (%)	N/A
N/A	Flare Traversable LT?	N/A	N/A	Flare Traversable RT?	N/A
N/A	Landing Length (in)	N/A	N/A	DWS Provided?	N/A
N/A	Landing Width (in)	N/A	N/A	DWS Contrast?	N/A
N/A	Landing Slope (%)	N/A	N/A	DWS Length (in)	N/A
N/A	Landing X Slope (%)	N/A	N/A	DWS Full Width?	N/A
N/A	Landing Curb? (Y/N)	N/A	N/A	DWS Offset (in)	N/A
N/A	Shared Landing?	N/A			
N/A	Gutter Ponding?	N/A	N/A	Gutter Slope (%)	N/A
N/A	Gutter Lip Ht (in)	N/A	N/A	Gutter X Slope (%)	N/A
N/A	Painted X Walk1?	No	N/A	Painted X Walk2?	No
	X Walk 1 Direction	To NE		X Walk 2 Direction	To NW
N/A	X Walk 1 Width (in)	N/A	N/A	X Walk 2 Width (in)	N/A
	X Walk 1 Slope (%)	2.5		X Walk 2 Slope (%)	0.7
	X Walk 1 X Slope (%)	0.8		X Walk 2 X Slope (%)	3.5

Remove & Replace Curb Ramp With Two New Directional Ramps or Equivalent.
