Access Compliance Report

Public Rights-of-Way

(Curb Ramps)

| Intersection ID: 4935 | Main Street: OLD_STATESVILLE_RD | Cross Street: HENDERSON_CR | Location: S |

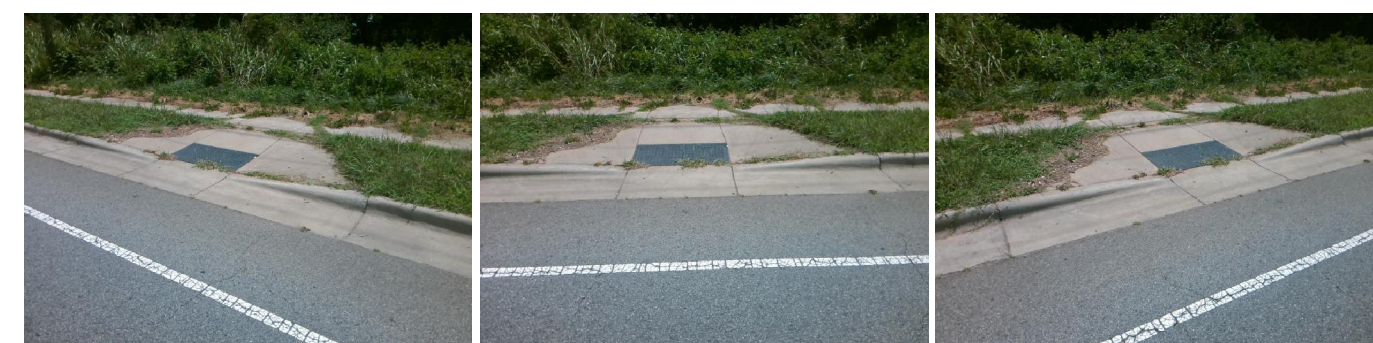
| Compliance | Description | Data | Compliance | Description | Data |
|---|---|---|---|---|---|
| N/A | Ramp Length (in) | 63.0 | No | Ramp Slope (%) | 9.5 |
| No | Ramp Width (in) | 46.5 | Yes | Ramp XSlope (%) | 1.0 |

Remove & Replace Entire Ramp.
