Access Compliance Report

Public Rights-of-Way

(Curb Ramps)

Intersection ID: 10780	Main Street: GESCO_ST	Cross Street: STATE_ST	Location: W
ADA ID: D85041BE7339	Ramp Type: Perp	Initial Pass/Fail: Fail	Overall Compliance: No
		Severity Score: 22.5

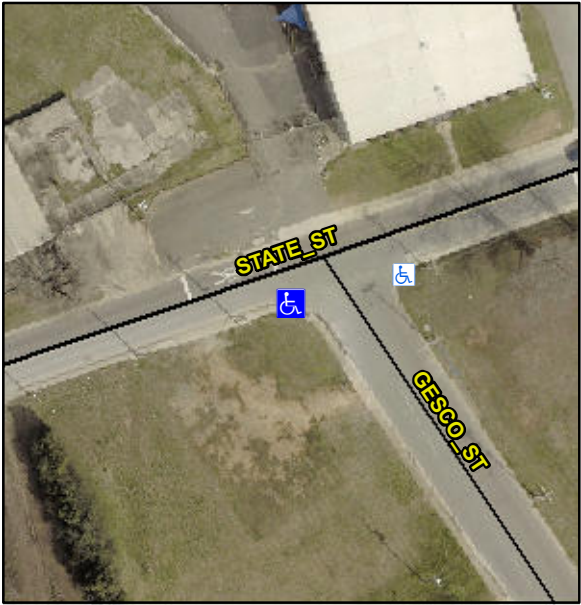
Possible Solutions:		Compliance	Description	Data	Compliance
	Remove & Replace Entire Ramp.		No	Ramp Length (in)	53.0	No
			No	Ramp Width (in)	36.0	No
			N/A	Flare Type LT	N/A	N/A
			N/A	Flare Slope LT (%)	N/A	N/A
			N/A	Flare Traversable LT?	N/A	N/A
			N/A	Landing Length (in)	N/A	N/A
			N/A	Landing Width (in)	N/A	N/A
			N/A	Landing Slope (%)	N/A	N/A
			N/A	Landing X Slope (%)	N/A	N/A
<p>Surveyor Notes:</p> <p>N/A</p> <p>PROW/ADA:</p> <p>Not Found, R304.5.1, R304.2.2, R304.5.3</p>			N/A	Flare Type RT	N/A	N/A
			N/A	Flare Slope RT (%)	N/A	N/A
			N/A	Flare Traversable RT?	N/A	N/A
			N/A	DWS Provided?	N/A	N/A
			N/A	DWS Contrast?	N/A	N/A
			N/A	DWS Length (in)	N/A	N/A
			N/A	DWS Full Width?	N/A	N/A
			N/A	DWS Offset (in)	N/A	N/A
			N/A	Gutter Ponding?	Yes	N/A
			N/A	Gutter Lip Ht (in)	N/A	N/A
<p>Total Cost:</p> <p>\$ 1850.00</p>			No	Painted X Walk1?	No	N/A

X Walk 1 Direction	To E	
			N/A	X Walk 1 Width (in)	N/A	N/A
				X Walk 1 Slope (%)	5.0	
				X Walk 1 X Slope (%)	0.1	
			N/A	Ramp inside XWalk1?	N/A	N/A
				Road Slope (%)	N/A	N/A
				Road X Slope (%)	N/A	N/A
			N/A	Any Obstructions?	N/A	N/A
				Obstruction Type		
			N/A	Storm Grate/Utility Hazard?	N/A	N/A
				Storm Grate/Utility Type		
			N/A			N/A
			Yes	Surface Condition? (G/P)		Good
