Access Compliance Report

Public Rights-of-Way

(Curb Ramps)

Intersection ID: 45437	Main Street: HENDERSON_CR	Cross Street: LABORDE_AV	Location: NW
ADA ID: DEF57081B192	Ramp Type: Perp	Initial Pass/Fail: Fail	Overall Compliance: No
Codes/Mitigation Info/Possible Solution			Severity Score: 60
			Field Measurements/Component Compliance

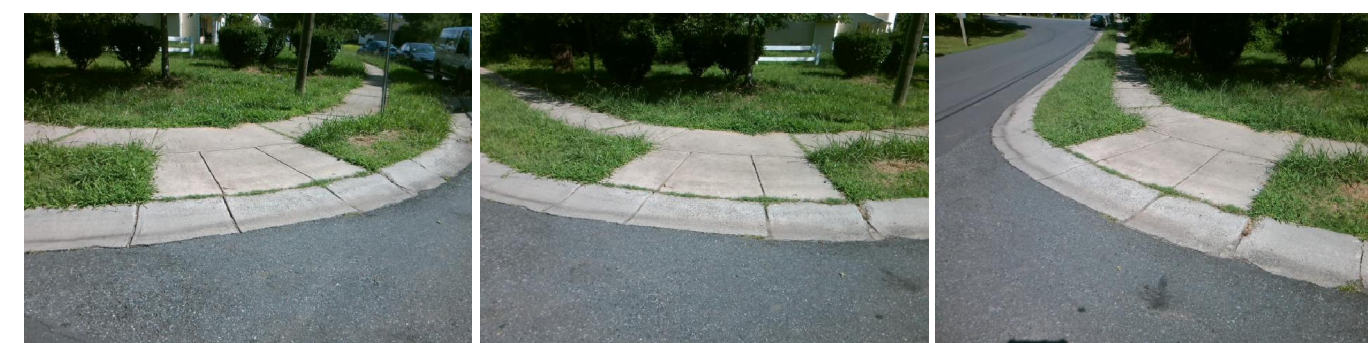
Compliance	Description	Data	Compliance	Description	Data
N/A	Ramp Length (in)	49.5	No	Ramp Slope (%)	15.7
No	Ramp Width (in)	30.0	Yes	Ramp XSlope (%)	1.5
N/A	Flare Type LT	N/A	N/A	Flare Type RT	N/A
N/A	Flare Slope LT (%)	N/A	N/A	Flare Slope RT (%)	N/A
N/A	Flare Traversable LT?	N/A	N/A	Flare Traversable RT?	N/A
N/A	Landing Length (in)	N/A	N/A	DWS Provided?	N/A
N/A	Landing Width (in)	N/A	N/A	DWS Contrast?	N/A
N/A	Landing Slope (%)	N/A	N/A	DWS Length (in)	N/A
N/A	Landing X Slope (%)	N/A	N/A	DWS Full Width?	N/A
N/A	Landing Curb? (Y/N)	N/A	N/A	DWS Offset (in)	N/A
N/A	Shared Landing?	N/A			
N/A	Gutter Ponding?	N/A	N/A	Gutter Slope (%)	N/A
N/A	Gutter Lip Ht (in)	N/A	N/A	Gutter X Slope (%)	N/A
N/A	Painted X Walk1?	No	N/A	Painted X Walk2?	N/A
	X Walk 1 Direction	To SE		X Walk 2 Direction	N/A
N/A	X Walk 1 Width (in)	N/A	N/A	X Walk 2 Width (in)	N/A
	X Walk 1 Slope (%)	4.3		X Walk 2 Slope (%)	N/A
	X Walk 1 X Slope (%)	0.1		X Walk 2 X Slope (%)	N/A

N/A	Ramp inside XWalk1?	N/A	N/A	Ramp inside XWalk2?	N/A
	Road Slope (%)	N/A	N/A	Clear Space?	N/A
	Road X Slope (%)	N/A	N/A	Clear Space to XWalk (in)	N/A
N/A	Any Obstructions?	N/A	N/A	Storm Grate/Utility Hazard?	N/A
	Obstruction Type			Storm Grate/Utility Type	
		N/A			N/A
			Yes	Surface Condition? (G/P)	Good

Remove & Replace Entire Ramp.
