Access Compliance Report

Public Rights-of-Way

(Curb Ramps)

| Intersection ID: 14085 | Main Street: CARLTON_AV | Cross Street: MT_VERNON_AV | Location: SE |

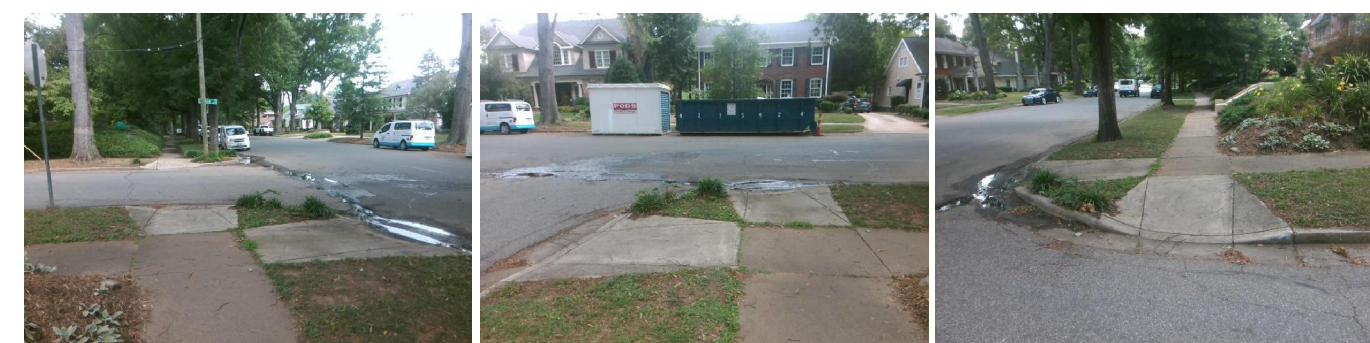
| ADA ID: DF21CA303254 | Ramp Type: Perp | Initial Pass/Fail: Fail | Overall Compliance: No |
| Severity Score: 21.25 | | | |

Not Found, R304.5.1, R304.5.3

| Compliance | Description | Data | Compliance | Description | Data |
|---|---|---|---|---|---|
| No | Ramp Width (in) | 45.0 | No | Ramp XSlope (%) | 6.8 |

Remove & Replace Entire Ramp.
