# Access Compliance Report

## Public Rights-of-Way

| Intersection ID: N/A | Main Street: DELUCA_DR | Cross Street: GALVIN_ST | Location: SE |
| ADA ID: DF797412DAEA | Ramp Type: Combination2Diag | Initial Pass/Fail: Pass | Overall Compliance: No |

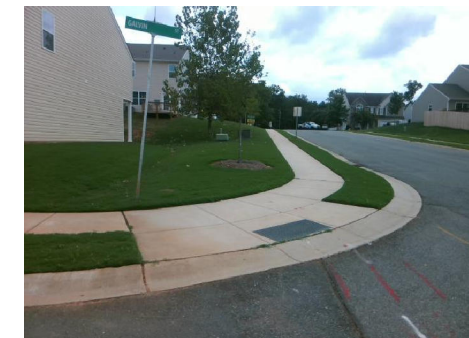
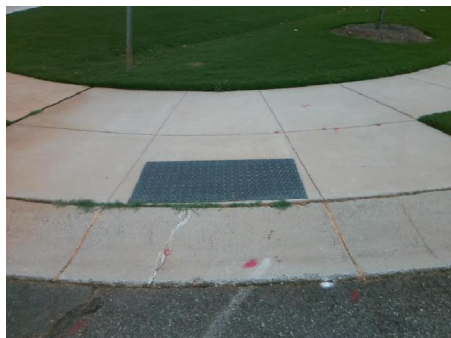
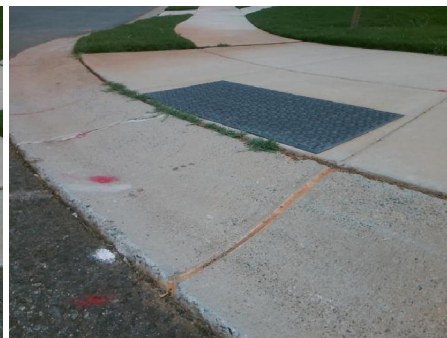
**Not Found, R304.5.3, R304.2.1, R304.2.2-Perp, R304.3.2-Para, R305.1.4, R302.7.2, R304.5.4**

| Compliance | Description | Data | Compliance | Description | Data |
|---|---|---|---|---|---|
| No | Ramp XSlope LT (%) | 3.5 | No | Ramp XSlope RT (%) | 2.6 |
| Yes | Ramp Width (in) | 49.0 | No | Ramp XSlope (%) | 4.0 |

**Remove & Replace Curb Ramp With Two New Directional Ramps or Equivalent. Remove & Replace Gutter.**
