Access Compliance Report

Public Rights-of-Way

| Intersection ID: 7375 | Main Street: N_TRYON_ST | Cross Street: TOM_HUNTER_RD | Location: NW |
| ADA ID: DF7B0893F8C8 | Ramp Type: MedianPerp | Initial Pass/Fail: Fail | Overall Compliance: No |

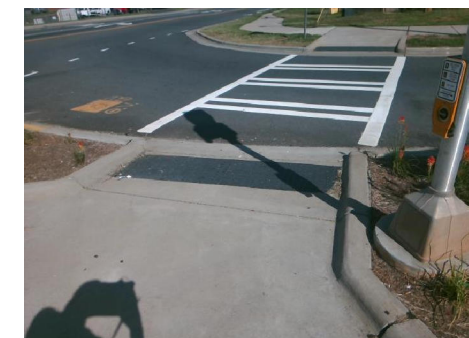
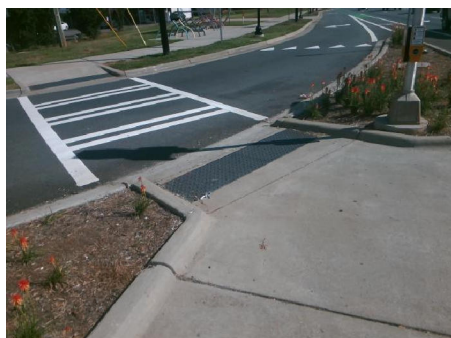
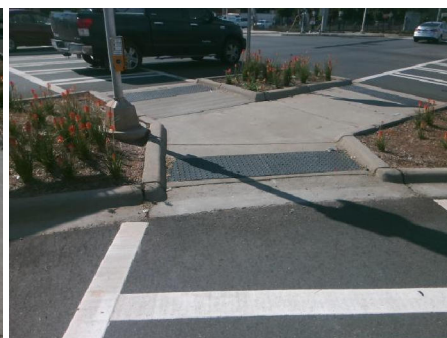
Not Found, R304.5.3

| Compliance | Description | Data | Compliance | Description | Data |
|---|---|---|---|---|---|
| Yes | Ramp Width (in) | 92.0 | No | Ramp XSlope (%) | 3.5 |

Remove & Replace Entire Ramp.
