Access Compliance Report

Public Rights-of-Way

(Curb Ramps)

Intersection ID: 14023	Main Street: NORWICH_PL	Cross Street: CHELVESTON_DR	Location: SE
ADA ID: E040A8FE517A	Ramp Type: Combination2Diag	Initial Pass/Fail: Fail	Overall Compliance: No
		Severity Score: 0

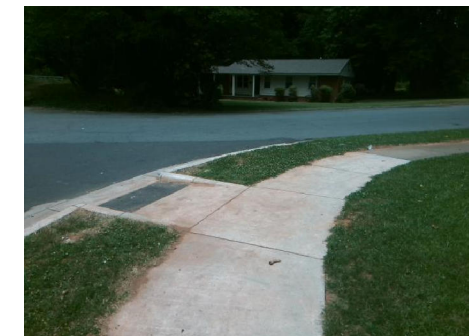
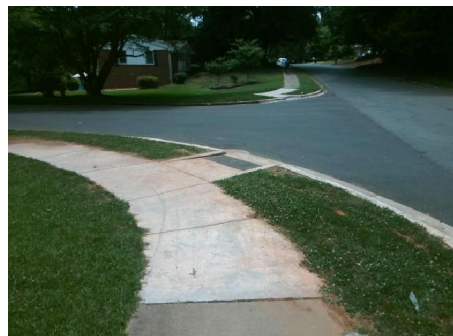
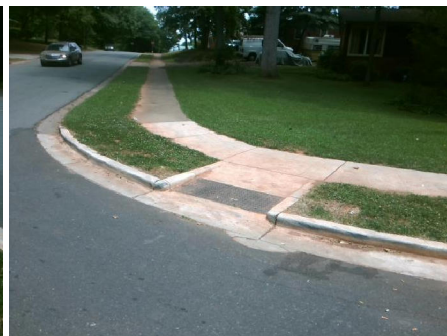
Not Found, R304.3.2

Compliance	Description	Data	Compliance	Description	Data
N/A	Ramp Length LT (in)	103.0	N/A	Ramp Length RT (in)	N/A
Yes	Ramp Width LT (in)	59.0	N/A	Ramp Width RT (in)	N/A
No	Ramp Slope LT (%)	8.6	N/A	Ramp Slope RT (%)	N/A
Yes	Ramp XSlope LT (%)	1.5	N/A	Ramp XSlope RT (%)	N/A
N/A	Ramp Length (in)	62.0	Yes	Ramp Slope (%)	8.2
Yes	Ramp Width (in)	59.5	Yes	Ramp XSlope (%)	1.5
N/A	Flare Type LT	N/A	N/A	Flare Type RT	N/A
N/A	Flare Slope LT (%)	N/A	N/A	Flare Slope RT (%)	N/A
N/A	Flare Traversable LT?	N/A	N/A	Flare Traversable RT?	N/A
N/A	Landing Length (in)	N/A	N/A	DWS Provided?	N/A
N/A	Landing Width (in)	N/A	N/A	DWS Contrast?	N/A
N/A	Landing Slope (%)	N/A	N/A	DWS Length (in)	N/A
N/A	Landing X Slope (%)	N/A	N/A	DWS Full Width?	N/A
N/A	Landing Curb? (Y/N)	N/A	N/A	DWS Offset (in)	N/A
N/A	Shared Landing?	N/A			
N/A	Gutter Ponding?	N/A	N/A	Gutter Slope (%)	N/A
N/A	Gutter Lip Ht (in)	N/A	N/A	Gutter X Slope (%)	N/A
N/A	Painted X Walk1?	No	N/A	Painted X Walk2?	No

X Walk 1 Direction	To SW		X Walk 2 Direction	To W
	X Walk 1 Width (in)	N/A		X Walk 2 Width (in)	N/A
	X Walk 1 Slope (%)	4.4		X Walk 2 Slope (%)	5.2
	X Walk 1 X Slope (%)	0.8		X Walk 2 X Slope (%)	5.8
N/A	Ramp inside XWalk1?	N/A	N/A	Ramp inside XWalk2?	N/A
	Road Slope (%)	3.1		Clear Space?	N/A
	Road X Slope (%)	7.7	N/A	Clear Space to XWalk (in)	N/A
			N/A	Any Obstruction?	N/A
				Obstruction Type	N/A
			N/A	Storm Grate/Utility Hazard?	N/A
				Storm Grate/Utility Type	N/A
Yes	Surface Condition? (G/P)	Good			
	Curb Slope (%)	11.9

Remove & Replace Curb Ramp With Two New Directional Ramps or Equivalent.
