# Access Compliance Report

## Public Rights-of-Way

| Intersection ID: 49289 | Main Street: ARDREY_CREST_DR | Cross Street: ELIZABETH_CREST_LN | Location: SW |
| ADA ID: E15D7800BBE0 | Ramp Type: Perp | Initial Pass/Fail: Fail | Overall Compliance: No |

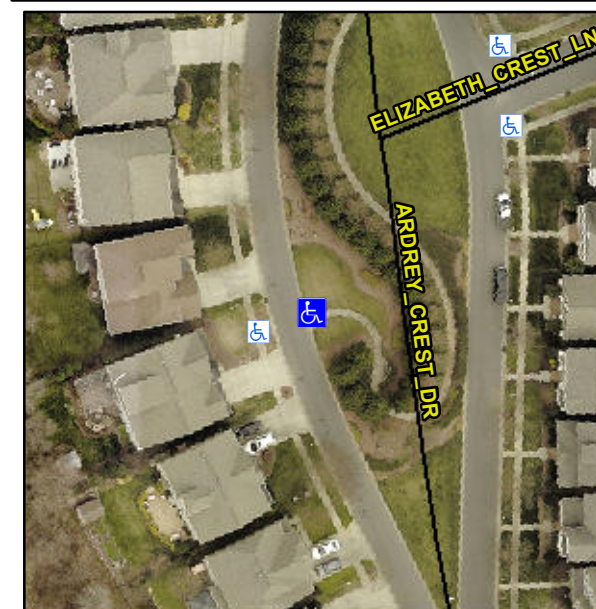
| Severity Score: 33.75 | | | |

**Not Found, R304.5.1**

| Compliance | Description | Data | Compliance | Description | Data |
|---|---|---|---|---|---|
| No | Ramp Width (in) | 47.0 | Yes | Ramp XSlope (%) | 1.3 |

**Remove & Replace Entire Ramp.**
