# Access Compliance Report

## Public Rights-of-Way

### (Curb Ramps)

| Intersection ID: 23437 | Main Street: MOSS_RD | Cross Street: S_TRYON_ST | Location: NW |

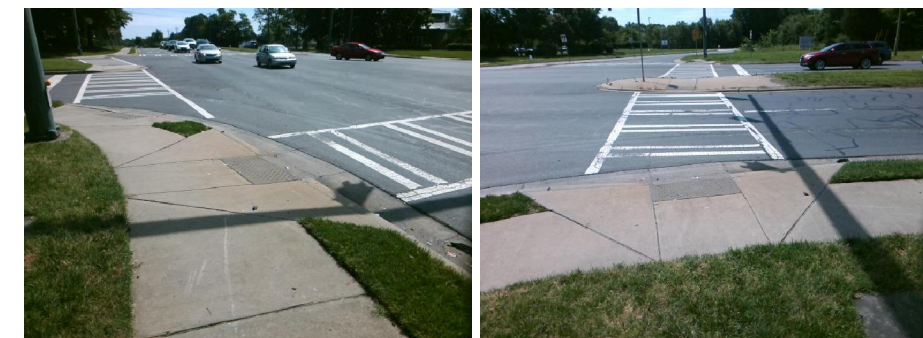
| ADA ID: E1BA3400E234 | Ramp Type: Perp | Initial Pass/Fail: Fail | Overall Compliance: No |
| | | Severity Score: 10 | |

**R304.5.1, R304.5.3**

| Compliance | Description | Data | Compliance | Description | Data |
|---|---|---|---|---|---|
| N/A | Ramp Length (in) | 59.0 | Yes | Ramp Slope (%) | 7.5 |
| No | Ramp Width (in) | 46.0 | No | Ramp XSlope (%) | 2.2 |

**Remove & Replace Entire Ramp.**
