# Access Compliance Report

## Public Rights-of-Way

### (Curb Ramps)

| Intersection ID: 2573 | Main Street: CAMBELLTON_DR | Cross Street: PELORUS_LN | Location: SW |

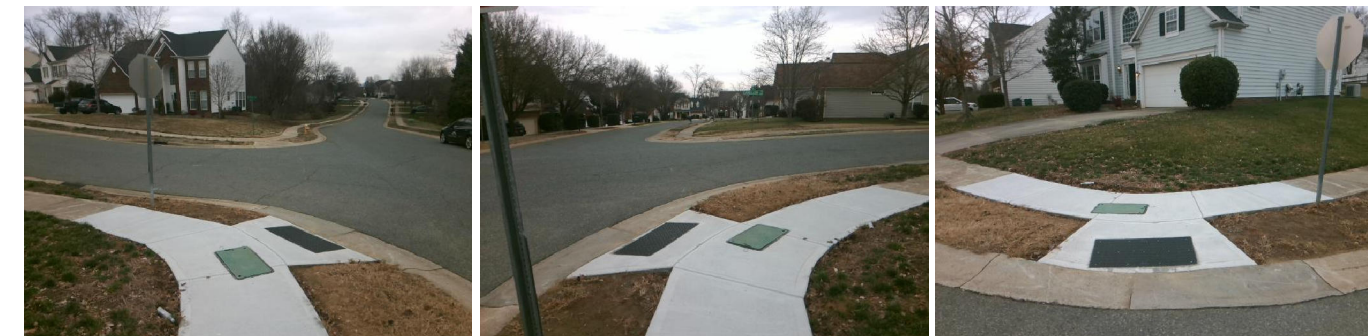
| Compliance | Description | Data | Compliance | Description | Data |
|---|---|---|---|---|---|
| N/A | Ramp Length (in) | 45.5 | No | Ramp Slope (%) | 14.7 |
| Yes | Ramp Width (in) | 64.0 | No | Ramp XSlope (%) | 3.6 |

**Remove & Replace Curb Ramp With Two New Directional Ramps or Equivalent.**
