Intersection ID: 18800	Main Street: PARK_RD	Cross Street: SENECA_PL	Location:	NE
ADA ID: E32BC56BB711	Ramp Type: PerpDiag	Initial Pass/Fail: Fail	Overall Compliance: No	Severity Score: 12.5

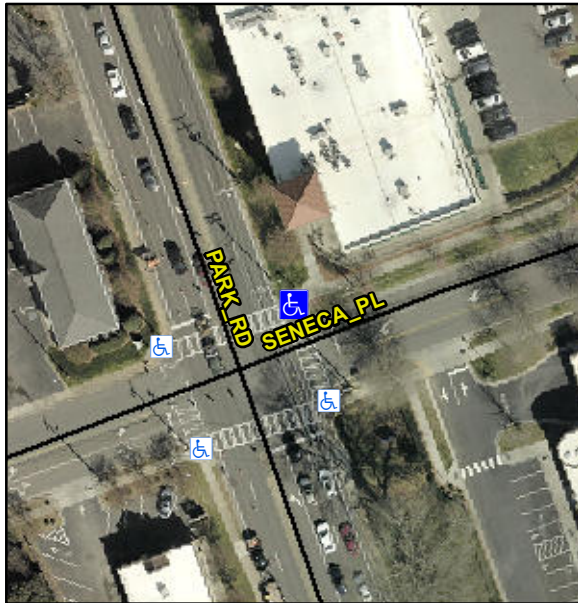
**N/A**

**Not Found, R304.2.2**

Compliance	Description	Data	Compliance	Description	Data
N/A	Ramp Length (in)	112.0	No	Ramp Slope (%)	8.9
Yes	Ramp Width (in)	49.0	Yes	Ramp XSlope (%)	0.8
N/A	Flare Type LT	N/A	N/A	Flare Type RT	N/A
N/A	Flare Slope LT (%)	N/A	N/A	Flare Slope RT (%)	N/A
N/A	Flare Traversable LT?	N/A	N/A	Flare Traversable RT?	N/A
N/A	Landing Length (in)	N/A	N/A	DWS Provided?	N/A
N/A	Landing Width (in)	N/A	N/A	DWS Contrast?	N/A
N/A	Landing Slope (%)	N/A	N/A	DWS Length (in)	N/A
N/A	Landing X Slope (%)	N/A	N/A	DWS Full Width?	N/A
N/A	Landing Curb? (Y/N)	N/A	N/A	DWS Offset (in)	N/A
N/A	Shared Landing?	N/A			
N/A	Gutter Ponding?	N/A	N/A	Gutter Slope (%)	N/A
N/A	Gutter Lip Ht (in)	N/A	N/A	Gutter X Slope (%)	N/A
N/A	Painted X Walk1?	Yes	N/A	Painted X Walk2?	Yes
	X Walk 1 Direction	To W		X Walk 2 Direction	To S
N/A	X Walk 1 Width (in)	110.0	N/A	X Walk 2 Width (in)	108.0
	X Walk 1 Slope (%)	3.3		X Walk 2 Slope (%)	2.2
	X Walk 1 X Slope (%)	0.5		X Walk 2 X Slope (%)	1.0

**Remove & Replace Curb Ramp With Two New Directional Ramps or Equivalent.**
