Access Compliance Report

Public Rights-of-Way

(Curb Ramps)

Intersection ID: 24385	Main Street: BEVERLY_CREST_BV	Cross Street: BECKMORE_PL	Location: SE
ADA ID: E560CCBFF9BC	Ramp Type: Perp	Initial Pass/Fail: Fail	Overall Compliance: No
Severity Score: 12.5			
Codes/Mitigation Info/Possible Solution		Field Measurements/Component Compliance

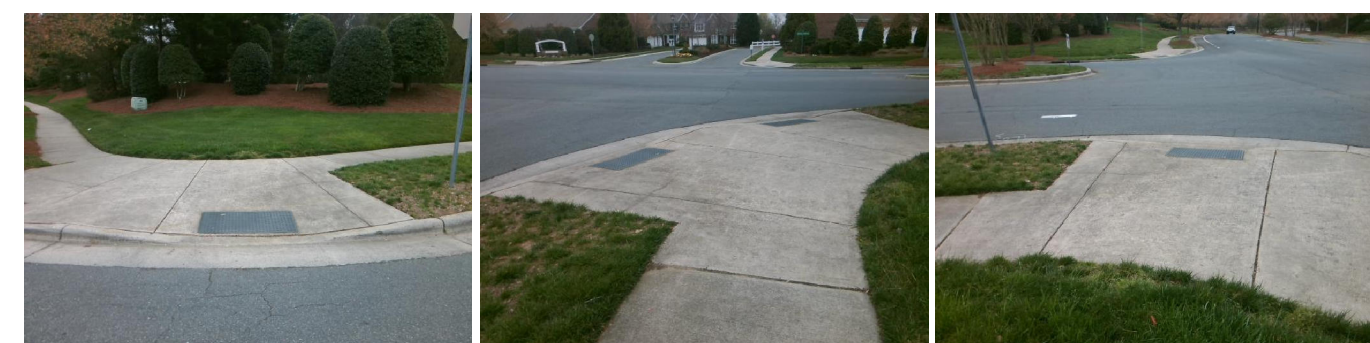
Not Found, R304.2.2

Compliance	Description	Data	Compliance	Description	Data
N/A	Ramp Length (in)	96.0	No	Ramp Slope (%)	8.4
Yes	Ramp Width (in)	81.0	Yes	Ramp XSlope (%)	0.9
N/A	Flare Type LT	N/A	N/A	Flare Type RT	N/A
N/A	Flare Slope LT (%)	N/A	N/A	Flare Slope RT (%)	N/A
N/A	Flare Traversable LT?	N/A	N/A	Flare Traversable RT?	N/A
N/A	Landing Length (in)	N/A	N/A	DWS Provided?	N/A
N/A	Landing Width (in)	N/A	N/A	DWS Contrast?	N/A
N/A	Landing Slope (%)	N/A	N/A	DWS Length (in)	N/A
N/A	Landing X Slope (%)	N/A	N/A	DWS Full Width?	N/A
N/A	Landing Curb? (Y/N)	N/A	N/A	DWS Offset (in)	N/A
N/A	Shared Landing?	N/A			
N/A	Gutter Ponding?	N/A	N/A	Gutter Slope (%)	N/A
N/A	Gutter Lip Ht (in)	N/A	N/A	Gutter X Slope (%)	N/A
N/A	Painted X Walk1?	No	N/A	Painted X Walk2?	N/A
	X Walk 1 Direction	To W		X Walk 2 Direction	N/A
N/A	X Walk 1 Width (in)	N/A	N/A	X Walk 2 Width (in)	N/A
	X Walk 1 Slope (%)	5.5		X Walk 2 Slope (%)	N/A
	X Walk 1 X Slope (%)	1.4		X Walk 2 X Slope (%)	N/A

N/A	Ramp inside XWalk1?	N/A	N/A	Ramp inside XWalk2?	N/A
	Road Slope (%)	N/A	N/A	Clear Space?	N/A
	Road X Slope (%)	N/A	N/A	Clear Space to XWalk (in)	N/A
N/A	Any Obstructions?	N/A	N/A	Storm Grate/Utility Hazard?	N/A
	Obstruction Type			Storm Grate/Utility Type	
		N/A			N/A
			Yes	Surface Condition? (G/P)	Good

Remove & Replace Entire Ramp.
