# Access Compliance Report

## Public Rights-of-Way

### (Curb Ramps)

Intersection ID: 5885	Main Street: ADONIS_CT	Cross Street: HELLEBORE_RD	Location: SW
ADA ID: E5D0EDA3C4B6	Ramp Type: Perp	Initial Pass/Fail: Fail	Overall Compliance: No
Severity Score: 1.25			
Codes/Mitigation Info/Possible Solution		Field Measurements/Component Compliance

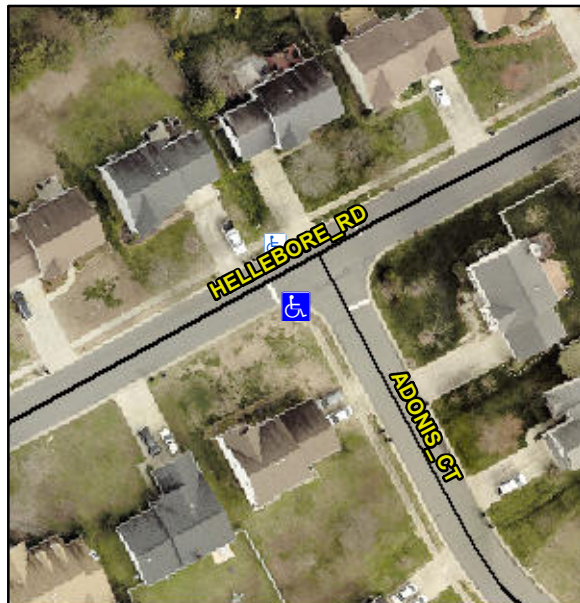
**Not Found, R304.5.3**

Compliance	Description	Data	Compliance	Description	Data
N/A	Ramp Length (in)	47.0	Yes	Ramp Slope (%)	6.9
Yes	Ramp Width (in)	80.0	No	Ramp XSlope (%)	2.3
N/A	Flare Type LT	N/A	N/A	Flare Type RT	N/A
N/A	Flare Slope LT (%)	N/A	N/A	Flare Slope RT (%)	N/A
N/A	Flare Traversable LT?	N/A	N/A	Flare Traversable RT?	N/A
N/A	Landing Length (in)	N/A	N/A	DWS Provided?	N/A
N/A	Landing Width (in)	N/A	N/A	DWS Contrast?	N/A
N/A	Landing Slope (%)	N/A	N/A	DWS Length (in)	N/A
N/A	Landing X Slope (%)	N/A	N/A	DWS Full Width?	N/A
N/A	Landing Curb? (Y/N)	N/A	N/A	DWS Offset (in)	N/A
N/A	Shared Landing?	N/A			
N/A	Gutter Ponding?	N/A	N/A	Gutter Slope (%)	N/A
N/A	Gutter Lip Ht (in)	N/A	N/A	Gutter X Slope (%)	N/A
N/A	Painted X Walk1?	No	N/A	Painted X Walk2?	N/A
	X Walk 1 Direction	To N		X Walk 2 Direction	N/A
N/A	X Walk 1 Width (in)	N/A	N/A	X Walk 2 Width (in)	N/A
	X Walk 1 Slope (%)	0.6		X Walk 2 Slope (%)	N/A
	X Walk 1 X Slope (%)	1.1		X Walk 2 X Slope (%)	N/A

N/A	Ramp inside XWalk1?	N/A	N/A	Ramp inside XWalk2?	N/A
	Road Slope (%)	N/A	N/A	Clear Space?	N/A
	Road X Slope (%)	N/A	N/A	Clear Space to XWalk (in)	N/A
N/A	Any Obstructions?	N/A	N/A	Storm Grate/Utility Hazard?	N/A
	Obstruction Type			Storm Grate/Utility Type	
		N/A			N/A
		Yes		Surface Condition? (G/P)	Good

**Remove & Replace Entire Ramp.**
