Access Compliance Report

Public Rights-of-Way (Curb Ramps)

Intersection ID: N/A	Main Street: CAMPBELL_DR	Cross Street: GREENBOOK_DR	Location: E
ADA ID: E5EE319F5CF6	Ramp Type: Combination2Diag	Initial Pass/Fail: Pass	Overall Compliance: No
		Severity Score: 7.5

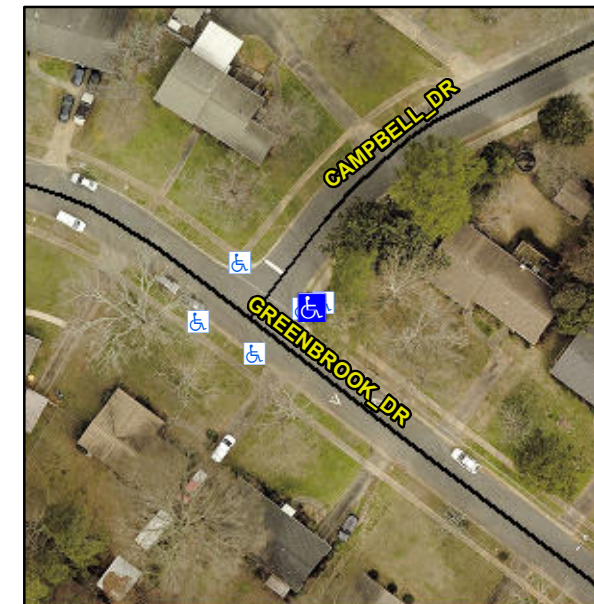
Not Found, R304.2.1, R304.2.2-Perp, R304.3.2-Para, R304.5.3, R302.7.2

Compliance	Description	Data	Compliance	Description	Data
N/A	Ramp Length LT (in)	34.0	N/A	Ramp Length RT (in)	20.0
Yes	Ramp Width LT (in)	70.0	Yes	Ramp Width RT (in)	53.0
Yes	Ramp Slope LT (%)	4.7	Yes	Ramp Slope RT (%)	5.2
Yes	Ramp XSlope LT (%)	1.5	Yes	Ramp XSlope RT (%)	1.2
N/A	Ramp Length (in)	24.0	Yes	Ramp Slope (%)	2.2
Yes	Ramp Width (in)	48.0	Yes	Ramp XSlope (%)	1.6
N/A	Flare Type LT	Sloped	N/A	Flare Type RT	Sloped
Yes	Flare Slope LT (%)	1.1	Yes	Flare Slope RT (%)	4.9
N/A	Flare Traversable LT?	Yes	N/A	Flare Traversable RT?	Yes
Yes	Landing Length (in)	70.0	Yes	DWS Provided?	Yes
No	Landing Width (in)	39.5	Yes	DWS Contrast?	Yes
No	Landing Slope (%)	3.9	Yes	DWS Length (in)	24.0
No	Landing X Slope (%)	4.1	Yes	DWS Full Width?	Yes
N/A	Landing Curb? (Y/N)	No	Yes	DWS Offset (in)	0.0
N/A	Shared Landing?	Yes			
Yes	Gutter Ponding?	No	Yes	Gutter Slope (%)	0.6
No	Gutter Lip Ht (in)	0.5	No	Gutter X Slope (%)	2.4
N/A	Painted X Walk1?	No	N/A	Painted X Walk2?	No

X Walk 1 Direction	To NW		X Walk 2 Direction	To SW
	X Walk 1 Width (in)	N/A		X Walk 2 Width (in)	N/A
	X Walk 1 Slope (%)	1.3		X Walk 2 Slope (%)	7.6
	X Walk 1 X Slope (%)	2.3		X Walk 2 X Slope (%)	0.2
N/A	Ramp inside XWalk1?	N/A	N/A	Ramp inside XWalk2?	N/A
	Road Slope (%)	2.7		Clear Space?	Yes
	Road X Slope (%)	1.1	N/A	Clear Space to XWalk (in)	N/A
			Yes	Any Obstruction?	No
				Obstruction Type	N/A
			Yes	Storm Grate/Utility Hazard?	No
				Storm Grate/Utility Type	N/A
			Yes	Surface Condition? (G/P)	Good
				Curb Slope (%)	17.5

Remove & Replace Curb Ramp With Two New Directional Ramps or Equivalent. Remove & Replace Gutter.
