Access Compliance Report

Public Rights-of-Way

(Curb Ramps)

Intersection ID: 50315	Main Street: PORTOLA_CT	Cross Street: ESMERALDA_DR	Location: SE
ADA ID: E66750D28E6D	Ramp Type: PerpDiag	Initial Pass/Fail: Fail	Overall Compliance: No
Severity Score: 10			
Codes/Mitigation Info/Possible Solution		Field Measurements/Component Compliance

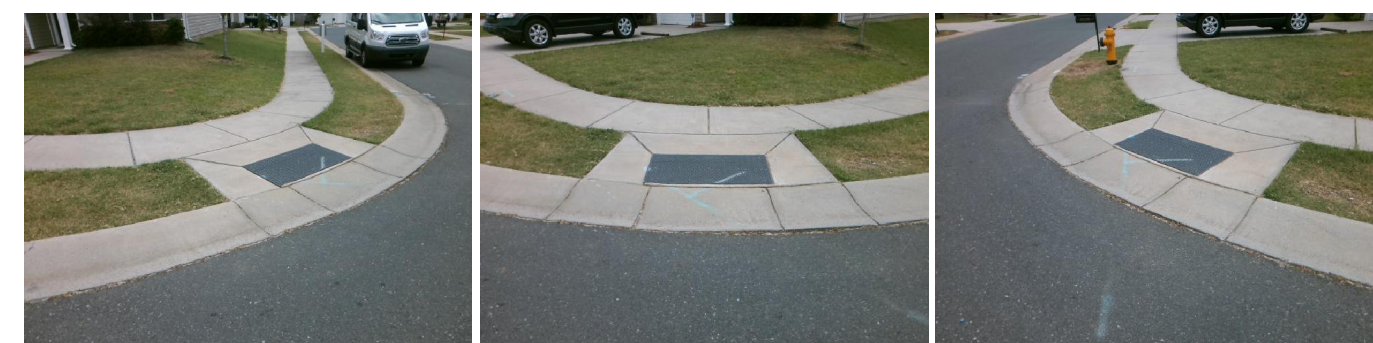
Not Found, R304.5.1, R304.5.3

Compliance	Description	Data	Compliance	Description	Data
N/A	Ramp Length (in)	49.0	Yes	Ramp Slope (%)	7.0
No	Ramp Width (in)	41.5	No	Ramp XSlope (%)	3.5
N/A	Flare Type LT	N/A	N/A	Flare Type RT	N/A
N/A	Flare Slope LT (%)	N/A	N/A	Flare Slope RT (%)	N/A
N/A	Flare Traversable LT?	N/A	N/A	Flare Traversable RT?	N/A
N/A	Landing Length (in)	N/A	N/A	DWS Provided?	N/A
N/A	Landing Width (in)	N/A	N/A	DWS Contrast?	N/A
N/A	Landing Slope (%)	N/A	N/A	DWS Length (in)	N/A
N/A	Landing X Slope (%)	N/A	N/A	DWS Full Width?	N/A
N/A	Landing Curb? (Y/N)	N/A	N/A	DWS Offset (in)	N/A
N/A	Shared Landing?	N/A			
N/A	Gutter Ponding?	N/A	N/A	Gutter Slope (%)	N/A
N/A	Gutter Lip Ht (in)	1.0	N/A	Gutter X Slope (%)	N/A
N/A	Painted X Walk1?	No	N/A	Painted X Walk2?	No
	X Walk 1 Direction	To N		X Walk 2 Direction	To W
N/A	X Walk 1 Width (in)	N/A	N/A	X Walk 2 Width (in)	N/A
	X Walk 1 Slope (%)	3.2		X Walk 2 Slope (%)	0.7
	X Walk 1 X Slope (%)	2.1		X Walk 2 X Slope (%)	5.4

N/A	Ramp inside XWalk1?	N/A	N/A	Ramp inside XWalk2?	N/A
	Road Slope (%)	5.5	N/A	Clear Space?	N/A
	Road X Slope (%)	1.9	N/A	Clear Space to XWalk (in)	N/A
N/A	Any Obstructions?	N/A	N/A	Storm Grate/Utility Hazard?	N/A
	Obstruction Type			Storm Grate/Utility Type	
		N/A			N/A
		Yes		Surface Condition? (G/P)	Good

Remove & Replace Curb Ramp With Two New Directional Ramps or Equivalent.
