Access Compliance Report

Public Rights-of-Way

(Curb Ramps)

Intersection ID: 28156	Main Street: ARBOR GROVE LN	Cross Street: OLIVIA LN	Location: NW
ADA ID: E6DE6EB2C1A6	Ramp Type: PerpDiag	Initial Pass/Fail: Fail	Overall Compliance: No
		Severity Score: 60

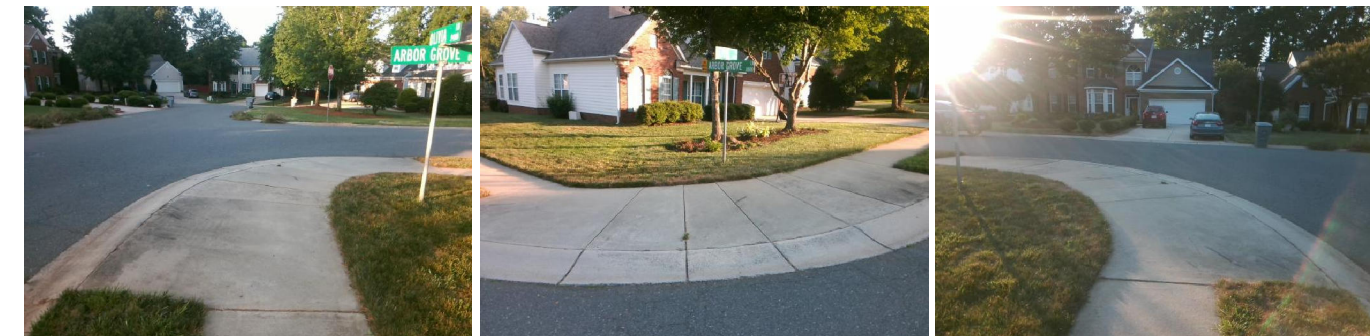
Not Found, R304.5.1, R304.2.2, R304.5.3

Compliance	Description	Data	Compliance	Description	Data
N/A	Ramp Length (in)	95.5	No	Ramp Slope (%)	8.4
No	Ramp Width (in)	25.0	No	Ramp XSlope (%)	6.1
N/A	Flare Type LT	N/A	N/A	Flare Type RT	N/A
N/A	Flare Slope LT (%)	N/A	N/A	Flare Slope RT (%)	N/A
N/A	Flare Traversable LT?	N/A	N/A	Flare Traversable RT?	N/A
N/A	Landing Length (in)	N/A	N/A	DWS Provided?	N/A
N/A	Landing Width (in)	N/A	N/A	DWS Contrast?	N/A
N/A	Landing Slope (%)	N/A	N/A	DWS Length (in)	N/A
N/A	Landing X Slope (%)	N/A	N/A	DWS Full Width?	N/A
N/A	Landing Curb? (Y/N)	N/A	N/A	DWS Offset (in)	N/A
N/A	Shared Landing?	N/A			
N/A	Gutter Ponding?	N/A	N/A	Gutter Slope (%)	N/A
N/A	Gutter Lip Ht (in)	N/A	N/A	Gutter X Slope (%)	N/A
N/A	Painted X Walk1?	No	N/A	Painted X Walk2?	No
	X Walk 1 Direction	To SW		X Walk 2 Direction	To SE
N/A	X Walk 1 Width (in)	N/A	N/A	X Walk 2 Width (in)	N/A
	X Walk 1 Slope (%)	3.6		X Walk 2 Slope (%)	2.9
	X Walk 1 X Slope (%)	4.0		X Walk 2 X Slope (%)	3.2

Remove & Replace Curb Ramp With Two New Directional Ramps or Equivalent.
