# Access Compliance Report

## Public Rights-of-Way

### (Curb Ramps)

Intersection ID: 49458	Main Street: PEBBLE_RUN_DR	Cross Street: TILLEY_MORRIS_RD	Location: SE
ADA ID: E8C63D5817AF	Ramp Type: Combination1	Initial Pass/Fail: Fail	Overall Compliance: No
			Severity Score: 33.75

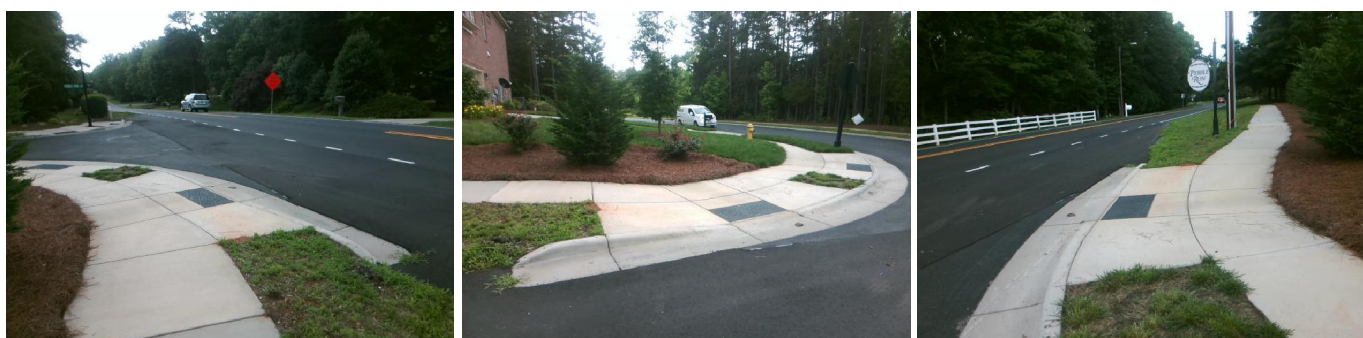
Possible Solutions:			<b>Compliance</b>	<b>Description</b>	<b>Data</b>	<b>Compliance</b>	<b>Description</b>	<b>Data</b>
	<b>Remove &amp; Replace Entire Ramp.</b>			N/A	Ramp Length LT (in)	53.0	N/A	Ramp Length RT (in)	41.0
				Yes	Ramp Width LT (in)	50.0	No	Ramp Width RT (in)	47.0
				No	Ramp Slope LT (%)	12.4	Yes	Ramp Slope RT (%)	1.3
				Yes	Ramp XSlope LT (%)	1.9	Yes	Ramp XSlope RT (%)	1.5
				N/A	Ramp Length (in)	47.0	Yes	Ramp Slope (%)	3.6
				No	Ramp Width (in)	47.5	Yes	Ramp XSlope (%)	0.1
				N/A	Flare Type LT	N/A	N/A	Flare Type RT	N/A
				N/A	Flare Slope LT (%)	N/A	N/A	Flare Slope RT (%)	N/A
				N/A	Flare Traversable LT?	N/A	N/A	Flare Traversable RT?	N/A
<p>Surveyor Notes:</p> <p><b>RP &amp; RT RP &lt; 5%</b></p> <p>PROW/ADA:</p> <p><b>Not Found, R304.5.1, R304.5.1, R304.3.2</b></p>				N/A	Landing Length (in)	N/A	N/A	DWS Provided?	N/A

N/A	Landing Width (in)	N/A	N/A	DWS Contrast?	N/A
				N/A	Landing Slope (%)	N/A	N/A	DWS Length (in)	N/A
				N/A	Landing X Slope (%)	N/A	N/A	DWS Full Width?	N/A
				N/A	Landing Curb? (Y/N)	N/A	N/A	DWS Offset (in)	N/A
				N/A	Shared Landing?	N/A			
				N/A	Gutter Ponding?	N/A	N/A	Gutter Slope (%)	N/A
				N/A	Gutter Lip Ht (in)	N/A	N/A	Gutter X Slope (%)	N/A
				N/A	Painted X Walk1?	No	N/A	Painted X Walk2?	N/A
					X Walk 1 Direction	To N		X Walk 2 Direction	N/A
					X Walk 1 Width (in)	N/A		X Walk 2 Width (in)	N/A
					X Walk 1 Slope (%)	3.4		X Walk 2 Slope (%)	N/A
					X Walk 1 X Slope (%)	2.1		X Walk 2 X Slope (%)	N/A
				N/A	Ramp inside XWalk1?	N/A	N/A	Ramp inside XWalk2?	N/A
					Road Slope (%)	N/A		Clear Space?	N/A
					Road X Slope (%)	N/A	N/A	Clear Space to XWalk (in)	N/A
							N/A	Any Obstruction?	N/A
								Obstruction Type	N/A
							N/A	Storm Grate/Utility Hazard?	N/A
								Storm Grate/Utility Type	N/A
