Access Compliance Report

Public Rights-of-Way

Intersection ID: 14278	Main Street: ROMARE_BEARDEN_DR	Cross Street: FARMER_ST	Location: SE
ADA ID: E9FBD2A05CCD	Ramp Type: Perp	Initial Pass/Fail: Fail	Overall Compliance: No
		Severity Score: 25

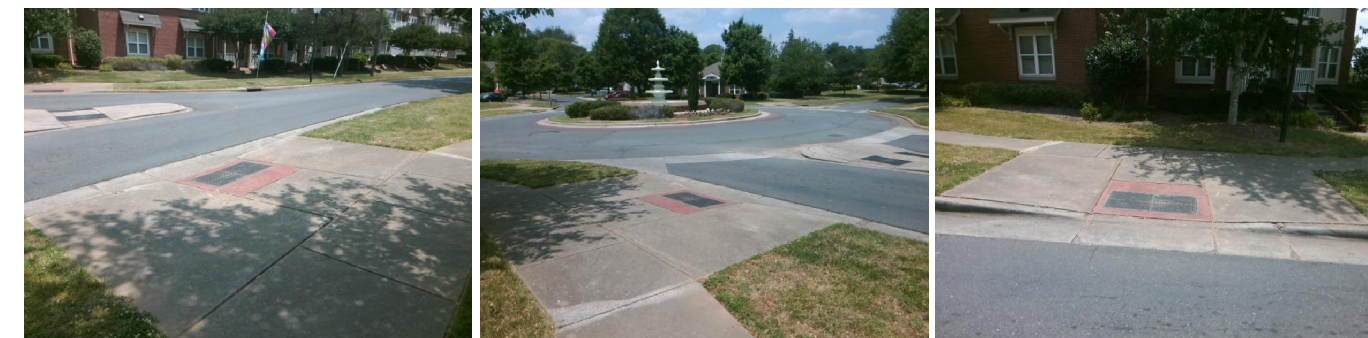
Compliance	Description	Data	Compliance	Description	Data
N/A	Ramp Length (in)	96.0	No	Ramp Slope (%)	8.7
Yes	Ramp Width (in)	57.0	No	Ramp XSlope (%)	6.1
N/A	Flare Type LT	N/A	N/A	Flare Type RT	N/A
N/A	Flare Slope LT (%)	N/A	N/A	Flare Slope RT (%)	N/A
N/A	Flare Traversable LT?	N/A	N/A	Flare Traversable RT?	N/A
N/A	Landing Length (in)	N/A	N/A	DWS Provided?	N/A
N/A	Landing Width (in)	N/A	N/A	DWS Contrast?	N/A
N/A	Landing Slope (%)	N/A	N/A	DWS Length (in)	N/A
N/A	Landing X Slope (%)	N/A	N/A	DWS Full Width?	N/A
N/A	Landing Curb? (Y/N)	N/A	N/A	DWS Offset (in)	N/A
N/A	Shared Landing?	N/A			
N/A	Gutter Ponding?	N/A	N/A	Gutter Slope (%)	N/A
N/A	Gutter Lip Ht (in)	N/A	N/A	Gutter X Slope (%)	N/A
N/A	Painted X Walk1?	No	N/A	Painted X Walk2?	N/A
	X Walk 1 Direction	To N		X Walk 2 Direction	N/A
N/A	X Walk 1 Width (in)	N/A	N/A	X Walk 2 Width (in)	N/A
	X Walk 1 Slope (%)	0.2		X Walk 2 Slope (%)	N/A
	X Walk 1 X Slope (%)	4.3		X Walk 2 X Slope (%)	N/A

Remove & Replace Entire Ramp.
