Access Compliance Report

Public Rights-of-Way (Curb Ramps)

Intersection ID: 12937	Main Street: E_W_T_HARRIS_BV	Cross Street: HICKORY_GROVE_RD	Location: SE
ADA ID: EA0F34DBFB37	Ramp Type: Combination1	Initial Pass/Fail: Fail	Overall Compliance: No
			Severity Score: 33.75

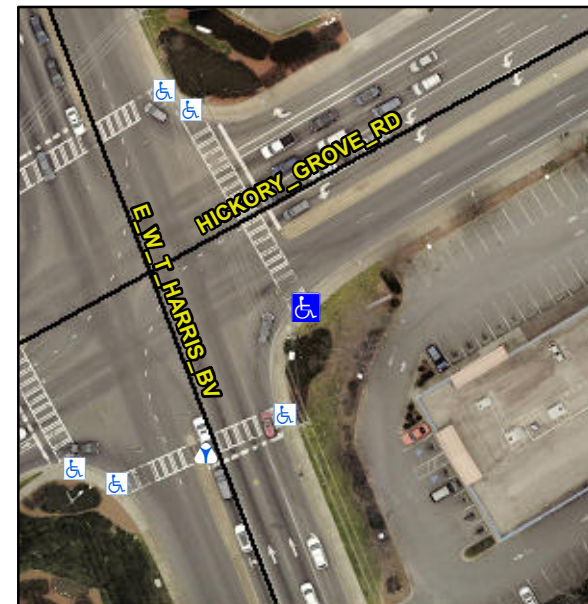
RT RP < 5%

Not Found, R304.5.1, R304.5.1, R304.2.2

Compliance	Description	Data	Compliance	Description	Data
N/A	Ramp Length LT (in)	69.0	N/A	Ramp Length RT (in)	74.0
Yes	Ramp Width LT (in)	48.0	No	Ramp Width RT (in)	47.0
Yes	Ramp Slope LT (%)	5.5	Yes	Ramp Slope RT (%)	2.6
Yes	Ramp XSlope LT (%)	1.9	Yes	Ramp XSlope RT (%)	0.3
N/A	Ramp Length (in)	24.0	No	Ramp Slope (%)	12.1
No	Ramp Width (in)	46.5	Yes	Ramp XSlope (%)	0.7
N/A	Flare Type LT	N/A	N/A	Flare Type RT	N/A
N/A	Flare Slope LT (%)	N/A	N/A	Flare Slope RT (%)	N/A
N/A	Flare Traversable LT?	N/A	N/A	Flare Traversable RT?	N/A
N/A	Landing Length (in)	N/A	N/A	DWS Provided?	N/A
N/A	Landing Width (in)	N/A	N/A	DWS Contrast?	N/A
N/A	Landing Slope (%)	N/A	N/A	DWS Length (in)	N/A
N/A	Landing X Slope (%)	N/A	N/A	DWS Full Width?	N/A
N/A	Landing Curb? (Y/N)	N/A	N/A	DWS Offset (in)	N/A
N/A	Shared Landing?	N/A			
N/A	Gutter Ponding?	N/A	N/A	Gutter Slope (%)	N/A
N/A	Gutter Lip Ht (in)	N/A	N/A	Gutter X Slope (%)	N/A
N/A	Painted X Walk1?	Yes	N/A	Painted X Walk2?	N/A

Remove & Replace Entire Ramp.
