Access Compliance Report

Public Rights-of-Way

(Curb Ramps)

Intersection ID: 28305	Main Street: COMMUNITY HOUSE RD	Cross Street: TAMARACK DR	Location:	N
ADA ID: EA5E982B9D4A	Ramp Type: Combination1Diag	Initial Pass/Fail: Fail	Overall Compliance: No	Severity Score: 0

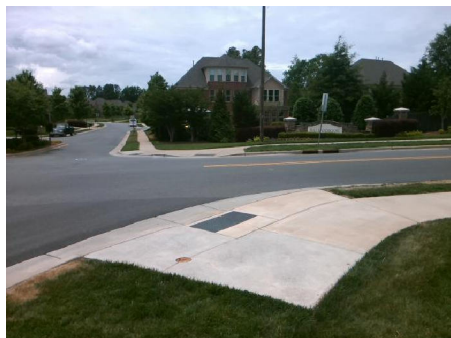
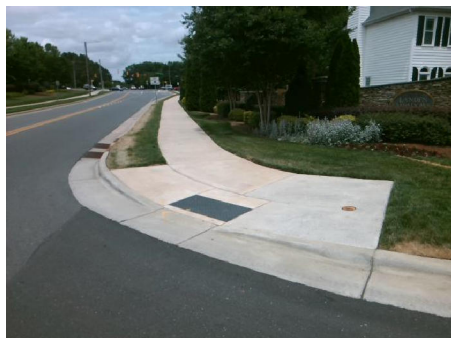
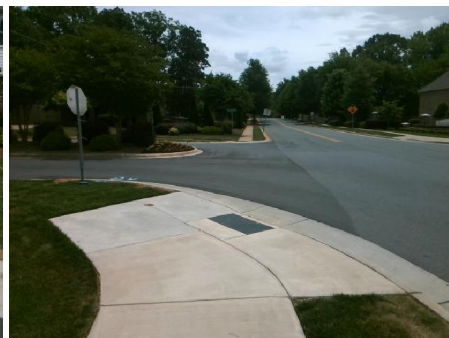
RP < 5 %, CURB WIDTH 44.0

Compliance	Description	Data	Compliance	Description	Data
N/A	Ramp Length LT (in)	41.0	N/A	Ramp Length RT (in)	48.0
Yes	Ramp Width LT (in)	70.0	Yes	Ramp Width RT (in)	71.0
Yes	Ramp Slope LT (%)	7.0	Yes	Ramp Slope RT (%)	7.1
Yes	Ramp XSlope LT (%)	1.5	No	Ramp XSlope RT (%)	2.8
N/A	Ramp Length (in)	48.0	Yes	Ramp Slope (%)	4.7
No	Ramp Width (in)	47.0	Yes	Ramp XSlope (%)	0.5
N/A	Flare Type LT	N/A	N/A	Flare Type RT	N/A
N/A	Flare Slope LT (%)	N/A	N/A	Flare Slope RT (%)	N/A
N/A	Flare Traversable LT?	N/A	N/A	Flare Traversable RT?	N/A
N/A	Landing Length (in)	N/A	N/A	DWS Provided?	N/A
N/A	Landing Width (in)	N/A	N/A	DWS Contrast?	N/A
N/A	Landing Slope (%)	N/A	N/A	DWS Length (in)	N/A
N/A	Landing X Slope (%)	N/A	N/A	DWS Full Width?	N/A
N/A	Landing Curb? (Y/N)	N/A	N/A	DWS Offset (in)	N/A
N/A	Shared Landing?	N/A			
N/A	Gutter Ponding?	N/A	N/A	Gutter Slope (%)	N/A
N/A	Gutter Lip Ht (in)	N/A	N/A	Gutter X Slope (%)	N/A
N/A	Painted X Walk1?	No	N/A	Painted X Walk2?	No

Remove & Replace Curb Ramp With Two New Directional Ramps or Equivalent.
