Access Compliance Report

Public Rights-of-Way

(Curb Ramps)

Intersection ID: 8615	Main Street: DARBY_AV	Cross Street: NELSON_AV	Location:	N
ADA ID: EAAA0E0230F1	Ramp Type: Perp	Initial Pass/Fail: Fail	Overall Compliance: No	Severity Score: 1.25

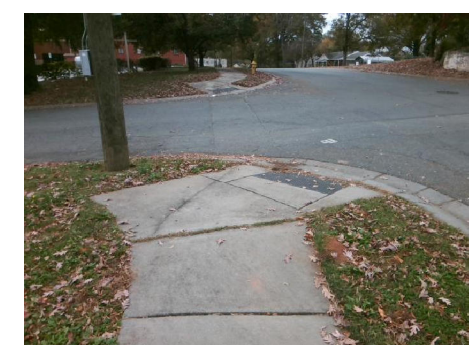
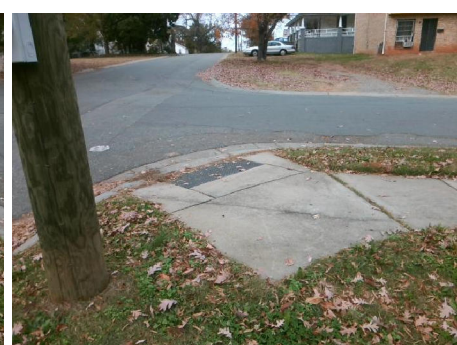
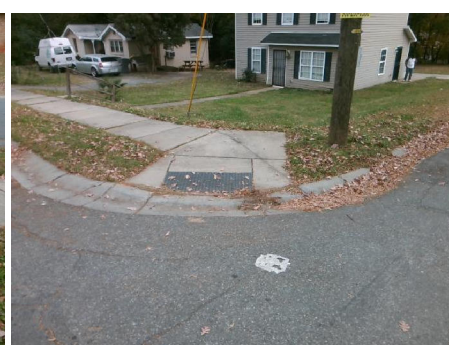
Possible Solutions:		Compliance			Description			Data			
	Remove & Replace Entire Ramp.		N/A	Ramp Length (in)		46.0		Yes	Ramp Slope (%)		6.7	
			Yes	Ramp Width (in)		48.0		No	Ramp XSlope (%)		2.5	
			N/A	Flare Type LT		N/A		N/A	Flare Type RT		N/A	
			N/A	Flare Slope LT (%)		N/A		N/A	Flare Slope RT (%)		N/A	
			N/A	Flare Traversable LT?		N/A		N/A	Flare Traversable RT?		N/A	
			N/A	Landing Length (in)		N/A		N/A	DWS Provided?		N/A	
			N/A	Landing Width (in)		N/A		N/A	DWS Contrast?		N/A	
			N/A	Landing Slope (%)		N/A		N/A	DWS Length (in)		N/A	
			N/A	Landing X Slope (%)		N/A		N/A	DWS Full Width?		N/A	
Surveyor Notes:		N/A			N/A		N/A		DWS Offset (in)		N/A	
PROW/ADA:		Not Found, R304.5.3			N/A		N/A					
					N/A		N/A		Gutter Slope (%)		N/A	
					N/A		N/A		Gutter X Slope (%)		N/A	
					N/A		No		Painted X Walk2?		N/A	
							To SW		X Walk 2 Direction		N/A

N/A		N/A		X Walk 2 Width (in)		N/A	
							3.1		X Walk 2 Slope (%)		N/A	
							9.9		X Walk 2 X Slope (%)		N/A	
					N/A		N/A		Ramp inside XWalk2?		N/A	
							N/A		Clear Space?		N/A	
							N/A		Clear Space to XWalk (in)		N/A	
					N/A		N/A		Storm Grate/Utility Hazard?		N/A	
									Storm Grate/Utility Type			
							N/A				N/A	
									Yes		Surface Condition? (G/P)	
											Good
