Access Compliance Report

Public Rights-of-Way

(Curb Ramps)

Intersection ID: 49791	Main Street: BAHIA_LN	Cross Street: BARLEY_LN	Location:	W
ADA ID: EB81CC99E35F	Ramp Type: Perp	Initial Pass/Fail: Fail	Overall Compliance: No	Severity Score: 1.25
Codes/Mitigation Info/Possible Solution		Field Measurements/Component Compliance

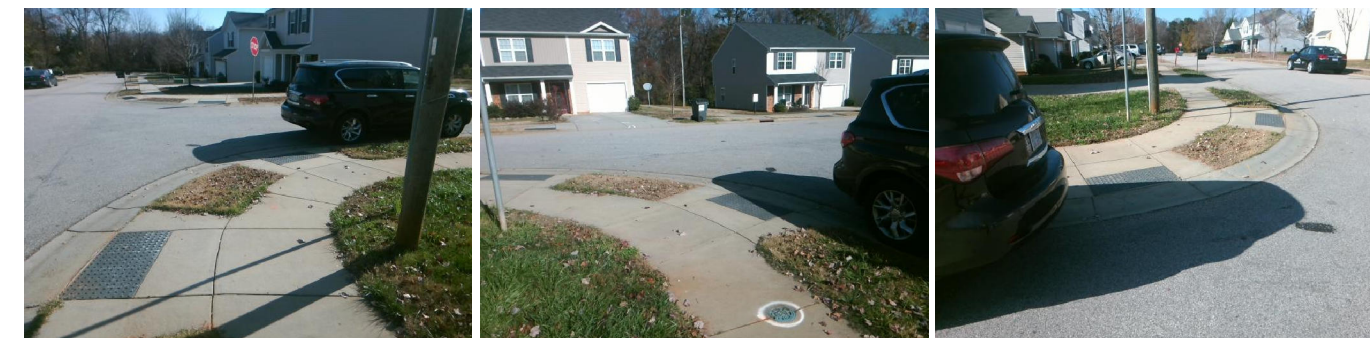
Not Found, R304.5.3

Compliance	Description	Data	Compliance	Description	Data
N/A	Ramp Length (in)	48.0	Yes	Ramp Slope (%)	5.1
Yes	Ramp Width (in)	48.0	No	Ramp XSlope (%)	3.2
N/A	Flare Type LT	N/A	N/A	Flare Type RT	N/A
N/A	Flare Slope LT (%)	N/A	N/A	Flare Slope RT (%)	N/A
N/A	Flare Traversable LT?	N/A	N/A	Flare Traversable RT?	N/A
N/A	Landing Length (in)	N/A	N/A	DWS Provided?	N/A
N/A	Landing Width (in)	N/A	N/A	DWS Contrast?	N/A
N/A	Landing Slope (%)	N/A	N/A	DWS Length (in)	N/A
N/A	Landing X Slope (%)	N/A	N/A	DWS Full Width?	N/A
N/A	Landing Curb? (Y/N)	N/A	N/A	DWS Offset (in)	N/A
N/A	Shared Landing?	N/A			
N/A	Gutter Ponding?	N/A	N/A	Gutter Slope (%)	N/A
N/A	Gutter Lip Ht (in)	0.3	N/A	Gutter X Slope (%)	N/A
N/A	Painted X Walk1?	No	N/A	Painted X Walk2?	N/A
	X Walk 1 Direction	To SE		X Walk 2 Direction	N/A
N/A	X Walk 1 Width (in)	N/A	N/A	X Walk 2 Width (in)	N/A
	X Walk 1 Slope (%)	0.8		X Walk 2 Slope (%)	N/A
	X Walk 1 X Slope (%)	2.2		X Walk 2 X Slope (%)	N/A

N/A	Ramp inside XWalk1?	N/A	N/A	Ramp inside XWalk2?	N/A
	Road Slope (%)	N/A	N/A	Clear Space?	N/A
	Road X Slope (%)	N/A	N/A	Clear Space to XWalk (in)	N/A
N/A	Any Obstructions?	N/A	N/A	Storm Grate/Utility Hazard?	N/A
	Obstruction Type			Storm Grate/Utility Type	
		N/A			N/A
			Yes	Surface Condition? (G/P)	Good

Remove & Replace Entire Ramp.
