Access Compliance Report

Public Rights-of-Way

(Curb Ramps)

Intersection ID: 14278	Main Street: ROMARE_BEARDEN_DR	Cross Street: FARMER_ST	Location: NW
ADA ID: EC2998A295C0	Ramp Type: Perp	Initial Pass/Fail: Fail	Overall Compliance: No
Severity Score: 13.75			
Codes/Mitigation Info/Possible Solution		Field Measurements/Component Compliance

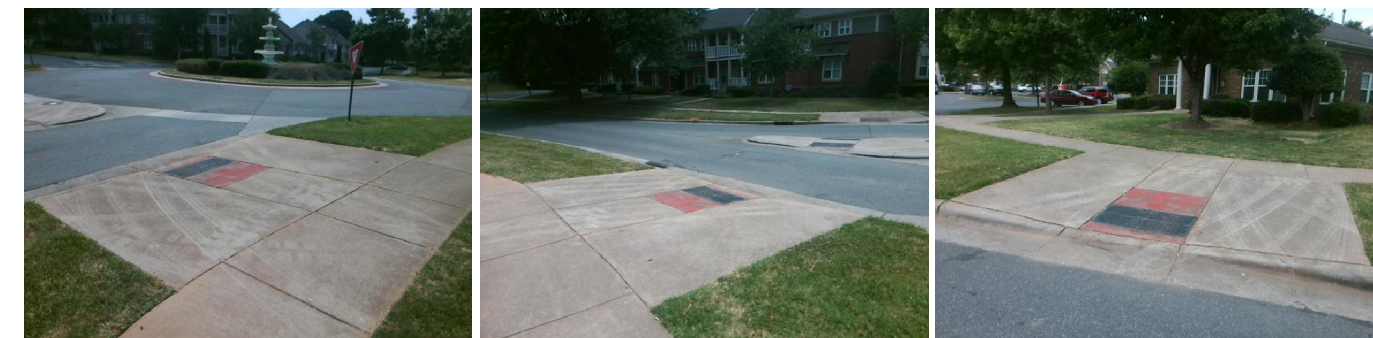
Not Found, R304.2.2, R304.5.3

Compliance	Description	Data	Compliance	Description	Data
N/A	Ramp Length (in)	116.0	No	Ramp Slope (%)	8.8
Yes	Ramp Width (in)	48.0	No	Ramp XSlope (%)	2.1
N/A	Flare Type LT	N/A	N/A	Flare Type RT	N/A
N/A	Flare Slope LT (%)	N/A	N/A	Flare Slope RT (%)	N/A
N/A	Flare Traversable LT?	N/A	N/A	Flare Traversable RT?	N/A
N/A	Landing Length (in)	N/A	N/A	DWS Provided?	N/A
N/A	Landing Width (in)	N/A	N/A	DWS Contrast?	N/A
N/A	Landing Slope (%)	N/A	N/A	DWS Length (in)	N/A
N/A	Landing X Slope (%)	N/A	N/A	DWS Full Width?	N/A
N/A	Landing Curb? (Y/N)	N/A	N/A	DWS Offset (in)	N/A
N/A	Shared Landing?	N/A			
N/A	Gutter Ponding?	N/A	N/A	Gutter Slope (%)	N/A
N/A	Gutter Lip Ht (in)	N/A	N/A	Gutter X Slope (%)	N/A
N/A	Painted X Walk1?	No	N/A	Painted X Walk2?	N/A
	X Walk 1 Direction	To E		X Walk 2 Direction	N/A
N/A	X Walk 1 Width (in)	N/A	N/A	X Walk 2 Width (in)	N/A
	X Walk 1 Slope (%)	1.5		X Walk 2 Slope (%)	N/A
	X Walk 1 X Slope (%)	0.6		X Walk 2 X Slope (%)	N/A

Remove & Replace Entire Ramp.
