Access Compliance Report

Public Rights-of-Way

(Curb Ramps)

Intersection ID: 8785	Main Street: HOOD_RD	Cross Street: CASA_LYNDA_LN	Location: SE
ADA ID: ED9886BA16E4	Ramp Type: Perp	Initial Pass/Fail: Fail	Overall Compliance: No
		Severity Score: 12.5	
Codes/Mitigation Info/Possible Solution		Field Measurements/Component Compliance

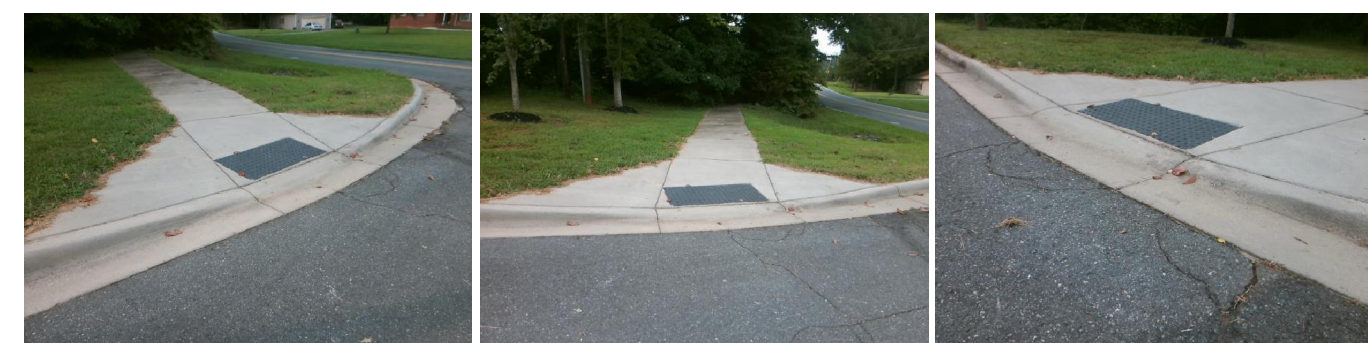
Not Found, R304.5.3

Compliance	Description	Data	Compliance	Description	Data
N/A	Ramp Length (in)	60.0	Yes	Ramp Slope (%)	7.4
Yes	Ramp Width (in)	57.5	No	Ramp XSlope (%)	6.5
N/A	Flare Type LT	N/A	N/A	Flare Type RT	N/A
N/A	Flare Slope LT (%)	N/A	N/A	Flare Slope RT (%)	N/A
N/A	Flare Traversable LT?	N/A	N/A	Flare Traversable RT?	N/A
N/A	Landing Length (in)	N/A	N/A	DWS Provided?	N/A
N/A	Landing Width (in)	N/A	N/A	DWS Contrast?	N/A
N/A	Landing Slope (%)	N/A	N/A	DWS Length (in)	N/A
N/A	Landing X Slope (%)	N/A	N/A	DWS Full Width?	N/A
N/A	Landing Curb? (Y/N)	N/A	N/A	DWS Offset (in)	N/A
N/A	Shared Landing?	N/A			
N/A	Gutter Ponding?	N/A	N/A	Gutter Slope (%)	N/A
N/A	Gutter Lip Ht (in)	N/A	N/A	Gutter X Slope (%)	N/A
N/A	Painted X Walk1?	No	N/A	Painted X Walk2?	N/A
	X Walk 1 Direction	To N		X Walk 2 Direction	N/A
N/A	X Walk 1 Width (in)	N/A	N/A	X Walk 2 Width (in)	N/A
	X Walk 1 Slope (%)	4.6		X Walk 2 Slope (%)	N/A
	X Walk 1 X Slope (%)	6.6		X Walk 2 X Slope (%)	N/A

N/A	Ramp inside XWalk1?	N/A	N/A	Ramp inside XWalk2?	N/A
	Road Slope (%)	N/A	N/A	Clear Space?	N/A
	Road X Slope (%)	N/A	N/A	Clear Space to XWalk (in)	N/A
N/A	Any Obstructions?	N/A	N/A	Storm Grate/Utility Hazard?	N/A
	Obstruction Type			Storm Grate/Utility Type	
		N/A			N/A
			Yes	Surface Condition? (G/P)	Good

Remove & Replace Entire Ramp.
