# Access Compliance Report

## Public Rights-of-Way

| Intersection ID: 31714 | Main Street: BLUE_ASH_LN | Cross Street: DEODORA_CEDAR_LN | Location: NW |
| ADA ID: EE14396D94B7 | Ramp Type: PerpDiag | Initial Pass/Fail: Fail | Overall Compliance: No |

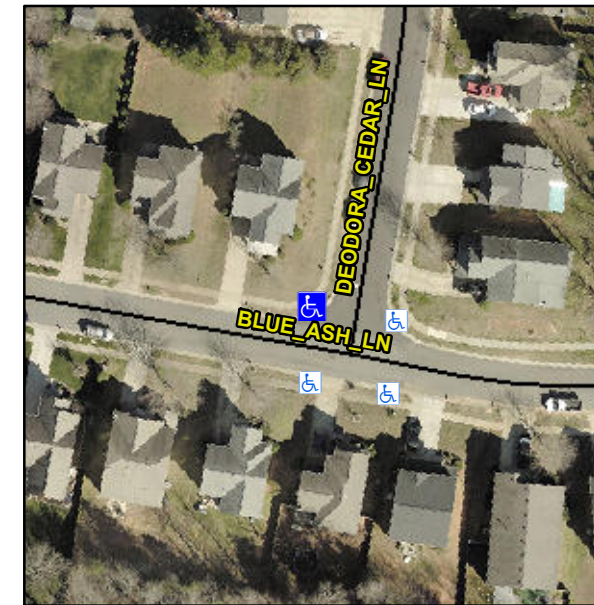
**Not Found, R304.5.1, R304.2.2, R304.5.3**

| Compliance | Description | Data | Compliance | Description | Data |
|---|---|---|---|---|---|
| N/A | Ramp Length (in) | 48.0 | No | Ramp Slope (%) | 9.2 |
| No | Ramp Width (in) | 40.5 | No | Ramp XSlope (%) | 4.5 |

**Remove & Replace Curb Ramp With Two New Directional Ramps or Equivalent.**
