Access Compliance Report

Public Rights-of-Way

(Curb Ramps)

Intersection ID: 50042	Main Street: METROPOLITAN_AV	Cross Street: S_KINGS_DR	Location: SE
ADA ID: F02DD45E742B	Ramp Type: Combination1	Initial Pass/Fail: Fail	Overall Compliance: No
			Severity Score: 33.75

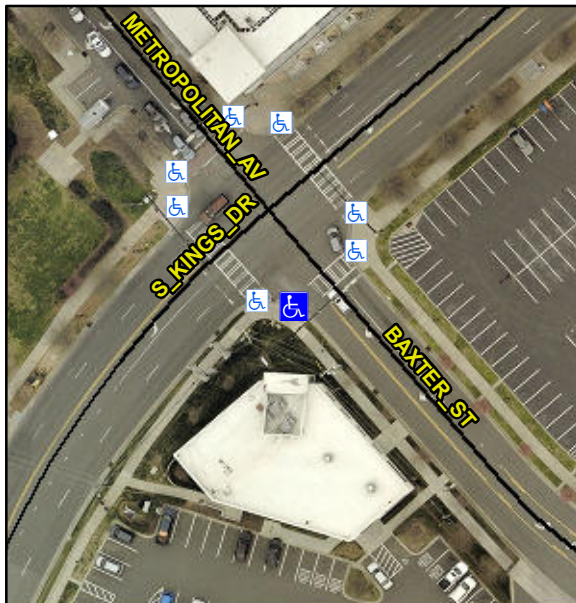
Not Found, R304.5.1, R304.5.3

Compliance	Description	Data	Compliance	Description	Data
N/A	Ramp Length LT (in)	48.0	N/A	Ramp Length RT (in)	42.0
Yes	Ramp Width LT (in)	71.0	Yes	Ramp Width RT (in)	71.0
Yes	Ramp Slope LT (%)	7.7	Yes	Ramp Slope RT (%)	6.0
Yes	Ramp XSlope LT (%)	0.9	No	Ramp XSlope RT (%)	4.8
N/A	Ramp Length (in)	48.0	Yes	Ramp Slope (%)	6.9
No	Ramp Width (in)	46.0	No	Ramp XSlope (%)	7.0
N/A	Flare Type LT	N/A	N/A	Flare Type RT	N/A
N/A	Flare Slope LT (%)	N/A	N/A	Flare Slope RT (%)	N/A
N/A	Flare Traversable LT?	N/A	N/A	Flare Traversable RT?	N/A
N/A	Landing Length (in)	N/A	N/A	DWS Provided?	N/A
N/A	Landing Width (in)	N/A	N/A	DWS Contrast?	N/A
N/A	Landing Slope (%)	N/A	N/A	DWS Length (in)	N/A
N/A	Landing X Slope (%)	N/A	N/A	DWS Full Width?	N/A
N/A	Landing Curb? (Y/N)	N/A	N/A	DWS Offset (in)	N/A
N/A	Shared Landing?	N/A			
N/A	Gutter Ponding?	N/A	N/A	Gutter Slope (%)	N/A
N/A	Gutter Lip Ht (in)	N/A	N/A	Gutter X Slope (%)	N/A
N/A	Painted X Walk1?	Yes	N/A	Painted X Walk2?	N/A

X Walk 1 Direction	To NE		X Walk 2 Direction	N/A
	X Walk 1 Width (in)	108.0		X Walk 2 Width (in)	N/A
	X Walk 1 Slope (%)	3.4		X Walk 2 Slope (%)	N/A
	X Walk 1 X Slope (%)	4.5		X Walk 2 X Slope (%)	N/A
N/A	Ramp inside XWalk1?	Yes	N/A	Ramp inside XWalk2?	N/A
	Road Slope (%)	N/A		Clear Space?	N/A
	Road X Slope (%)	N/A	N/A	Clear Space to XWalk (in)	N/A
			N/A	Any Obstruction?	N/A
				Obstruction Type	N/A
			N/A	Storm Grate/Utility Hazard?	N/A
				Storm Grate/Utility Type	N/A
Yes	Surface Condition? (G/P)	Good			
	Curb Slope (%)	13.1

Remove & Replace Entire Ramp.
