Access Compliance Report

Public Rights-of-Way

(Curb Ramps)

Intersection ID: 45172	Main Street: ELDON_DR	Cross Street: LINDEN_TREE_LN	Location: SW
ADA ID: F0E353ED13DA	Ramp Type: Perp	Initial Pass/Fail: Fail	Overall Compliance: No
Severity Score: 37.5			
Codes/Mitigation Info/Possible Solution		Field Measurements/Component Compliance

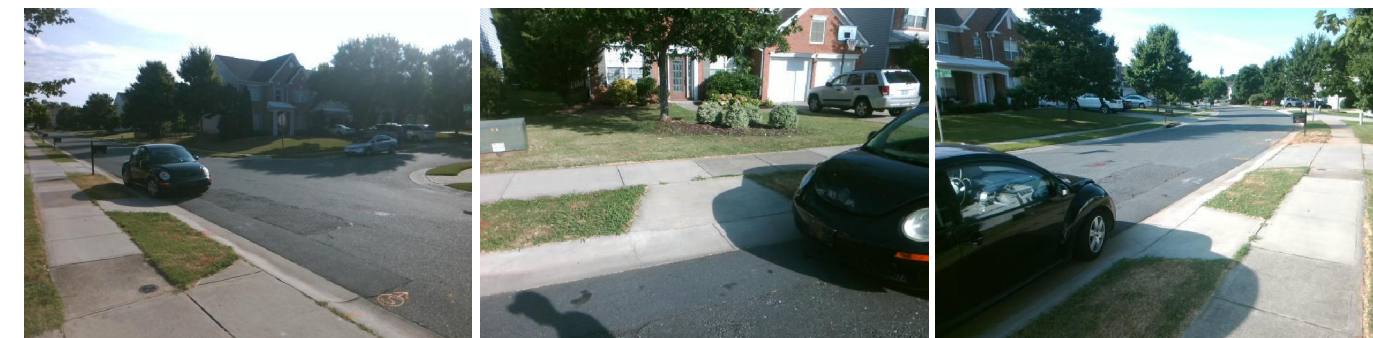
Not Found, R304.2.2, R304.5.3

Compliance	Description	Data	Compliance	Description	Data
N/A	Ramp Length (in)	47.0	No	Ramp Slope (%)	14.5
Yes	Ramp Width (in)	60.0	No	Ramp XSlope (%)	5.4
N/A	Flare Type LT	N/A	N/A	Flare Type RT	N/A
N/A	Flare Slope LT (%)	N/A	N/A	Flare Slope RT (%)	N/A
N/A	Flare Traversable LT?	N/A	N/A	Flare Traversable RT?	N/A
N/A	Landing Length (in)	N/A	N/A	DWS Provided?	N/A
N/A	Landing Width (in)	N/A	N/A	DWS Contrast?	N/A
N/A	Landing Slope (%)	N/A	N/A	DWS Length (in)	N/A
N/A	Landing X Slope (%)	N/A	N/A	DWS Full Width?	N/A
N/A	Landing Curb? (Y/N)	N/A	N/A	DWS Offset (in)	N/A
N/A	Shared Landing?	N/A			
N/A	Gutter Ponding?	N/A	N/A	Gutter Slope (%)	N/A
N/A	Gutter Lip Ht (in)	N/A	N/A	Gutter X Slope (%)	N/A
N/A	Painted X Walk1?	No	N/A	Painted X Walk2?	N/A
	X Walk 1 Direction	To SE		X Walk 2 Direction	N/A
N/A	X Walk 1 Width (in)	N/A	N/A	X Walk 2 Width (in)	N/A
	X Walk 1 Slope (%)	2.6		X Walk 2 Slope (%)	N/A
	X Walk 1 X Slope (%)	1.0		X Walk 2 X Slope (%)	N/A

Remove & Replace Entire Ramp.
