Access Compliance Report

Public Rights-of-Way

(Curb Ramps)

Intersection ID: 14278	Main Street: ROMARE_BEARDEN_DR	Cross Street: FARMER_ST	Location:	N
ADA ID: F5B135B2FE66	Ramp Type: MedianPerp	Initial Pass/Fail: Fail	Overall Compliance: No	Severity Score: 13.75
Codes/Mitigation Info/Possible Solution		Field Measurements/Component Compliance

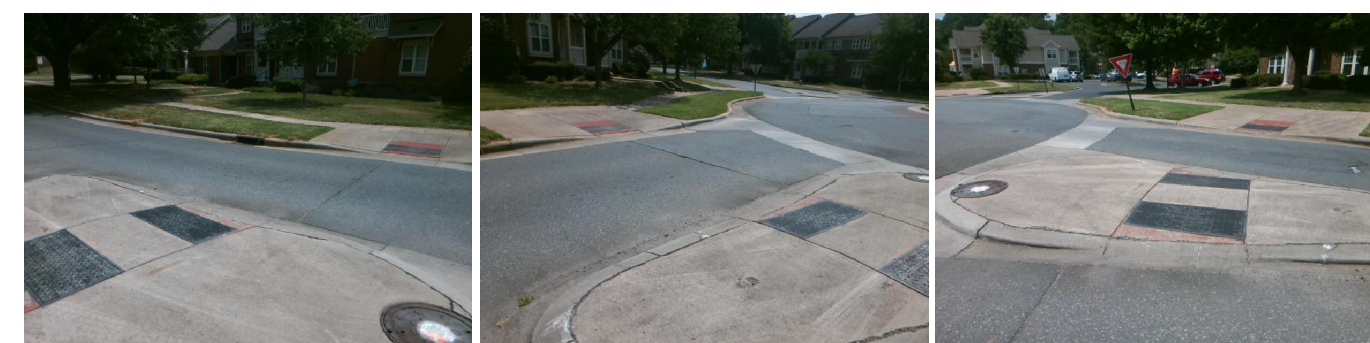
Not Found, R304.2.2, R304.5.3

Compliance	Description	Data	Compliance	Description	Data
N/A	Ramp Length (in)	40.0	No	Ramp Slope (%)	9.0
Yes	Ramp Width (in)	48.0	No	Ramp XSlope (%)	3.3
N/A	Flare Type LT	N/A	N/A	Flare Type RT	N/A
N/A	Flare Slope LT (%)	N/A	N/A	Flare Slope RT (%)	N/A
N/A	Flare Traversable LT?	N/A	N/A	Flare Traversable RT?	N/A
N/A	Landing Length (in)	N/A	N/A	DWS Provided?	N/A
N/A	Landing Width (in)	N/A	N/A	DWS Contrast?	N/A
N/A	Landing Slope (%)	N/A	N/A	DWS Length (in)	N/A
N/A	Landing X Slope (%)	N/A	N/A	DWS Full Width?	N/A
N/A	Landing Curb? (Y/N)	N/A	N/A	DWS Offset (in)	N/A
N/A	Shared Landing?	N/A			
N/A	Gutter Ponding?	N/A	N/A	Gutter Slope (%)	N/A
N/A	Gutter Lip Ht (in)	N/A	N/A	Gutter X Slope (%)	N/A
N/A	Painted X Walk1?	No	N/A	Painted X Walk2?	N/A
	X Walk 1 Direction	To E		X Walk 2 Direction	N/A
N/A	X Walk 1 Width (in)	N/A	N/A	X Walk 2 Width (in)	N/A
	X Walk 1 Slope (%)	0.7		X Walk 2 Slope (%)	N/A
	X Walk 1 X Slope (%)	2.0		X Walk 2 X Slope (%)	N/A

N/A	Ramp inside XWalk1?	N/A	N/A	Ramp inside XWalk2?	N/A
	Road Slope (%)	N/A	N/A	Clear Space?	N/A
	Road X Slope (%)	N/A	N/A	Clear Space to XWalk (in)	N/A
N/A	Any Obstructions?	N/A	N/A	Storm Grate/Utility Hazard?	N/A
	Obstruction Type			Storm Grate/Utility Type	
		N/A			N/A
			Yes	Surface Condition? (G/P)	Good

Remove & Replace Entire Ramp.
