# Access Compliance Report

## Public Rights-of-Way

### (Curb Ramps)

| Intersection ID: 14471 | Main Street: DILWORTH_RD | Cross Street: LINGANORE_PL | Location: NE |

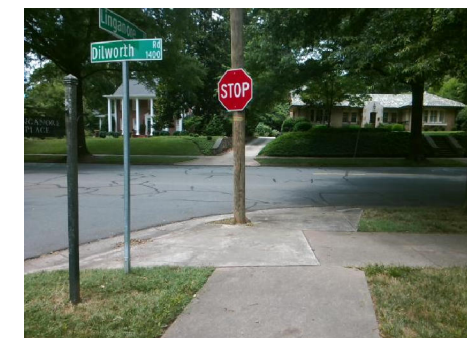
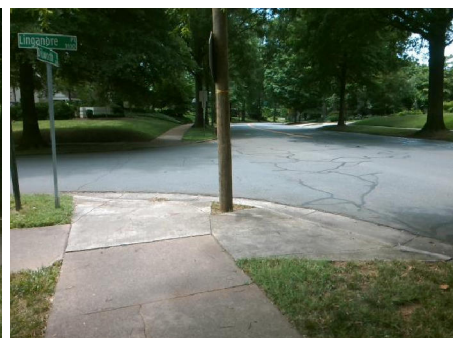
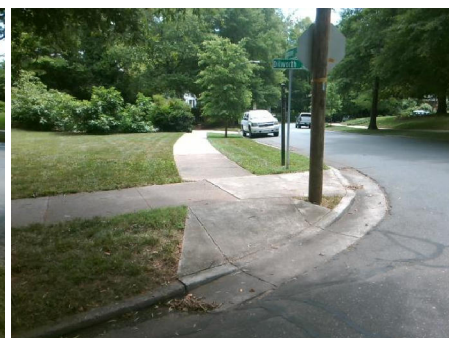
| Compliance | Description | Data | Compliance | Description | Data |
|---|---|---|---|---|---|
| N/A | Ramp Length (in) | 55.0 | Yes | Grade Break? | Yes |
| Yes | Ramp Slope (%) | 5.1 | No | Grade Break XSlope (%) | 3.2 |
| No | Ramp XSlope (%) | 2.3 | | | |
| Yes | Landing Length (in) | 72.0 | No | DWS Provided? | No |
| No | Landing X Slope (%) | 2.5 | N/A | DWS Full Width? | No |

**Remove & Replace Entire Ramp.  
Remove & Replace Gutter.**
