Access Compliance Report

Public Rights-of-Way

| Intersection ID: 10022718 | Main Street: CAROWINDS_BV | Cross Street: N/A | Location: NW |
| ADA ID: F836C5147C94 | Ramp Type: PerpDiag | Initial Pass/Fail: Fail | Overall Compliance: No |

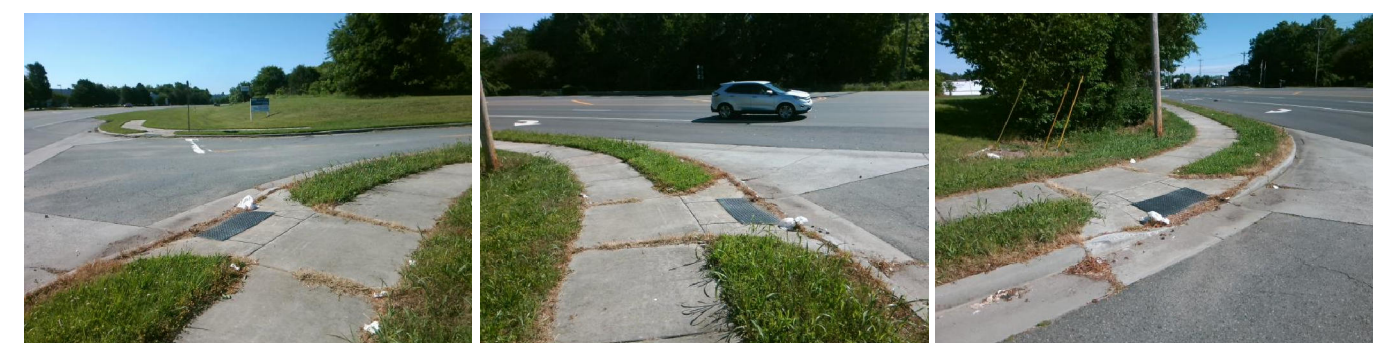
| Codes/Mitigation Info/Possible Solution | | | Field Measurements/Component Compliance | | |
|--|---|---|---|---|---|
| | Remove & Replace Curb Ramp With Two New Directional Ramps or Equivalent. | | No | Ramp Length (in) | 50.0 |
| | | | No | Ramp Width (in) | 37.5 |
