Access Compliance Report

Public Rights-of-Way

(Curb Ramps)

| Intersection ID: 50602 | Main Street: RHODORA_RD | Cross Street: CEDARFIELD_RD | Location: NE |

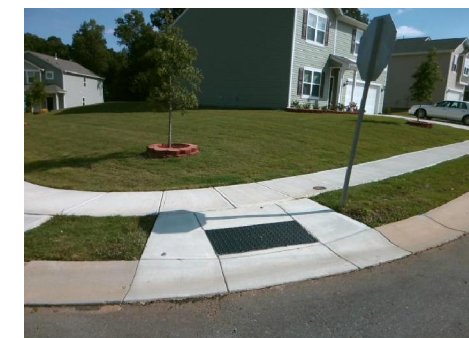
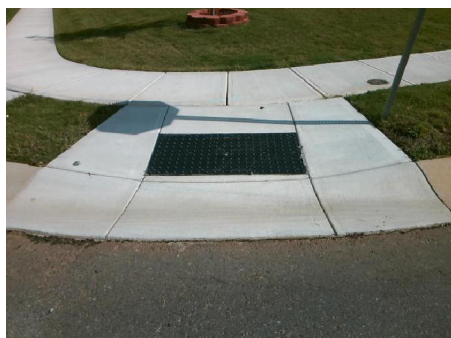
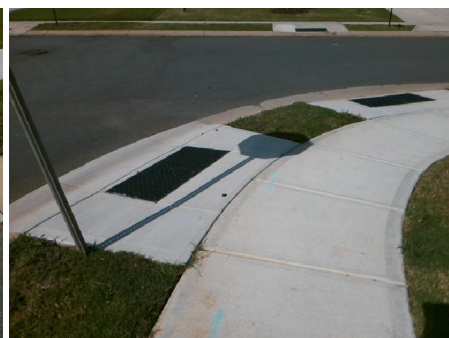
| ADA ID: F94B9F2D43B4 | Ramp Type: Perp | Initial Pass/Fail: Fail | Overall Compliance: No |

Not Found, R304.5.1, R304.2.2, R304.5.3

| Compliance | Description | Data | Compliance | Description | Data |
|---|---|---|---|---|---|
| N/A | Ramp Length (in) | 50.0 | No | Ramp Slope (%) | 12.1 |
| No | Ramp Width (in) | 47.0 | No | Ramp XSlope (%) | 3.2 |

Remove & Replace Entire Ramp.
