# Access Compliance Report

## Public Rights-of-Way

### (Curb Ramps)

Intersection ID: 4677	Main Street: OLD_STATESVILLE_RD	Cross Street: HENDERSON_RD	Location: E
ADA ID: FA36BC2D59EB	Ramp Type: Perp	Initial Pass/Fail: Fail	Overall Compliance: No
			Severity Score: 33.75

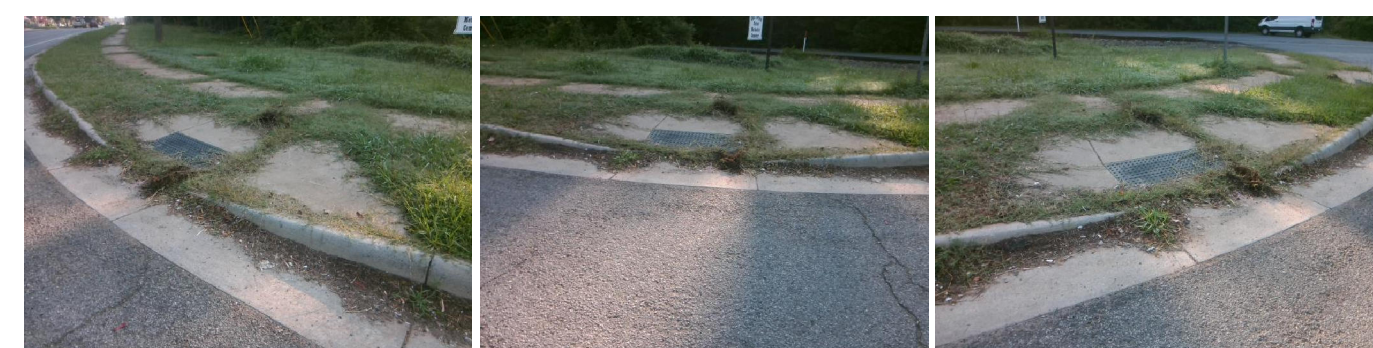
X Walk 1 Direction	<b>To W</b>	
			<b>N/A</b>	X Walk 1 Width (in)	<b>N/A</b>	<b>N/A</b>
				X Walk 1 Slope (%)	<b>6.4</b>	
				X Walk 1 X Slope (%)	<b>2.6</b>	
			<b>N/A</b>	Ramp inside XWalk1?	<b>N/A</b>	<b>N/A</b>
<p>Surveyor Notes:</p> <p><b>N/A</b></p> <p>PROW/ADA:</p> <p><b>Not Found, R304.5.1, R304.2.2</b></p>			<b>N/A</b>	Road Slope (%)	<b>N/A</b>	<b>N/A</b>
			<b>N/A</b>	Road X Slope (%)	<b>N/A</b>	<b>N/A</b>
			<b>N/A</b>	Any Obstructions?	<b>N/A</b>	<b>N/A</b>
				Obstruction Type		
					<b>N/A</b>	<b>N/A</b>
			<b>Yes</b>	Surface Condition? (G/P)		<b>Good</b>
Total Cost:		\$ 1850.00

Possible Solutions:		<b>Compliance</b>	<b>Description</b>	<b>Data</b>	
	<b>Remove &amp; Replace Entire Ramp.</b>		<b>N/A</b>	Ramp Length (in)	<b>60.0</b>	<b>No</b>
			<b>No</b>	Ramp Width (in)	<b>45.0</b>	<b>Yes</b>
			<b>N/A</b>	Flare Type LT	<b>N/A</b>	<b>N/A</b>
			<b>N/A</b>	Flare Slope LT (%)	<b>N/A</b>	<b>N/A</b>
			<b>N/A</b>	Flare Traversable LT?	<b>N/A</b>	<b>N/A</b>
			<b>N/A</b>	Landing Length (in)	<b>N/A</b>	<b>N/A</b>
			<b>N/A</b>	Landing Width (in)	<b>N/A</b>	<b>N/A</b>
			<b>N/A</b>	Landing Slope (%)	<b>N/A</b>	<b>N/A</b>
			<b>N/A</b>	Landing X Slope (%)	<b>N/A</b>	<b>N/A</b>
			<b>N/A</b>	Landing Curb? (Y/N)	<b>N/A</b>	<b>N/A</b>
			<b>N/A</b>	Shared Landing?	<b>N/A</b>	
			<b>N/A</b>	Gutter Ponding?	<b>N/A</b>	<b>N/A</b>
			<b>N/A</b>	Gutter Lip Ht (in)	<b>N/A</b>	<b>N/A</b>
			<b>N/A</b>	Painted X Walk1?	<b>No</b>	<b>N/A</b>
