Access Compliance Report

Public Rights-of-Way

(Curb Ramps)

Intersection ID: 11226	Main Street: AIRLIE_ST	Cross Street: EASTWOOD_DR	Location:	N
ADA ID: FBEBEBBB5875	Ramp Type: Perp	Initial Pass/Fail: Fail	Overall Compliance: No	Severity Score: 22.5

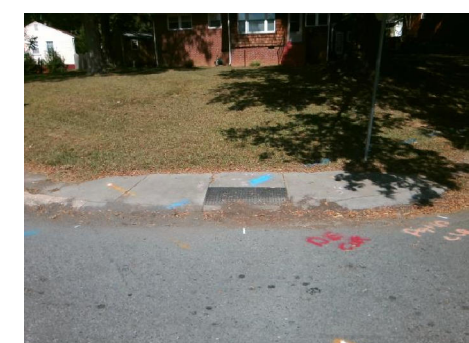
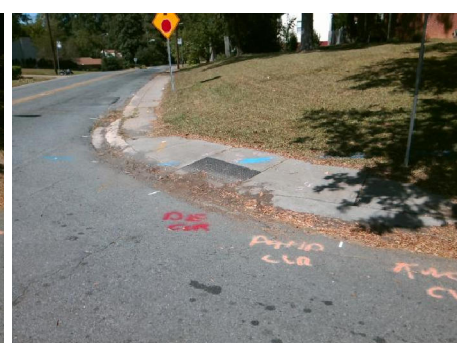
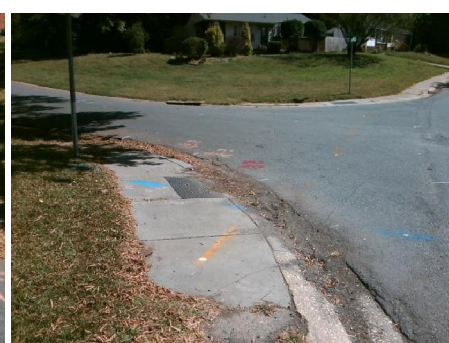
Possible Solutions:		Compliance	Description	Data
	Remove & Replace Entire Ramp.		No	Ramp Length (in)	55.5
			No	Ramp Width (in)	47.0
			N/A	Flare Type LT	N/A
			N/A	Flare Slope LT (%)	N/A
			N/A	Flare Traversable LT?	N/A
			N/A	Landing Length (in)	N/A
			N/A	Landing Width (in)	N/A
			N/A	Landing Slope (%)	N/A
			N/A	Landing X Slope (%)	N/A
<p>Surveyor Notes:</p> <p>N/A</p> <p>PROW/ADA:</p> <p>Not Found, R304.5.1, R304.2.2, R304.5.3</p>			N/A	Flare Type RT	N/A
			N/A	Flare Slope RT (%)	N/A
			N/A	Flare Traversable RT?	N/A
			N/A	DWS Provided?	N/A
			N/A	DWS Contrast?	N/A
			N/A	DWS Length (in)	N/A
			N/A	DWS Full Width?	N/A
			N/A	DWS Offset (in)	N/A
			N/A	Gutter Ponding?	N/A
			N/A	Gutter Lip Ht (in)	N/A
			No	Painted X Walk1?	N/A
				X Walk 1 Direction	To SE
			N/A	X Walk 1 Width (in)	N/A
				X Walk 1 Slope (%)	1.7
				X Walk 1 X Slope (%)	1.6

N/A	Ramp inside XWalk1?	N/A
			N/A	Road Slope (%)	N/A
			N/A	Road X Slope (%)	N/A
			N/A	Any Obstructions?	N/A
				Obstruction Type	
Total Cost:		\$ 1850.00	N/A	Storm Grate/Utility Hazard?	N/A
				Storm Grate/Utility Type	
			N/A		N/A
			Yes	Surface Condition? (G/P)	Good
