Access Compliance Report

Public Rights-of-Way

(Curb Ramps)

Intersection ID: 52531	Main Street: WILSHIRE_PL	Cross Street: BAMBOO_ST	Location: SE
ADA ID: FD19505EF285	Ramp Type: Perp	Initial Pass/Fail: Fail	Overall Compliance: No
		Severity Score: 1.25

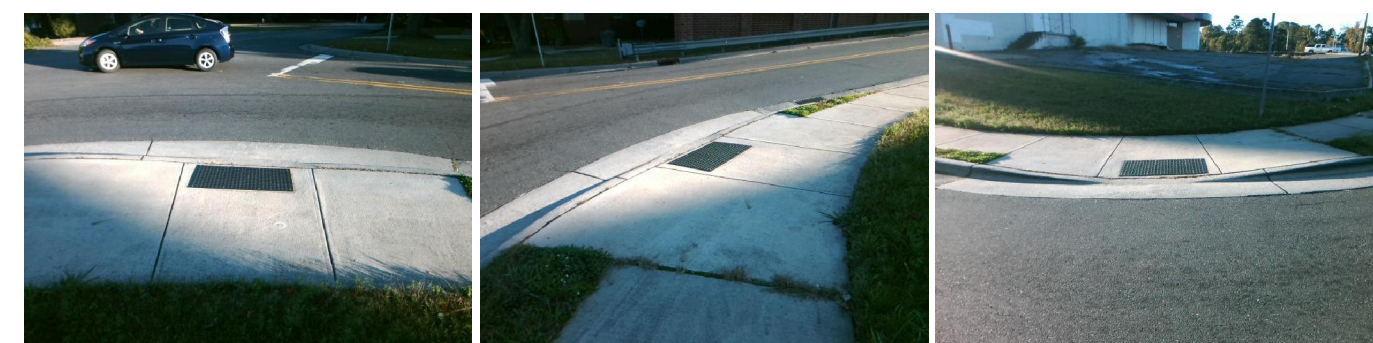
Possible Solutions:		Compliance	Description	Data
	Remove & Replace Entire Ramp.		N/A	Ramp Length (in)	87.0
			Yes	Ramp Width (in)	53.0
			N/A	Flare Type LT	N/A
			N/A	Flare Slope LT (%)	N/A
			N/A	Flare Traversable LT?	N/A
			N/A	Landing Length (in)	N/A
			N/A	Landing Width (in)	N/A
			N/A	Landing Slope (%)	N/A
			N/A	Landing X Slope (%)	N/A
<p>Surveyor Notes:</p> <p>N/A</p> <p>PROW/ADA:</p> <p>R304.5.3</p>			N/A	Flare Type RT	N/A
			N/A	Flare Slope RT (%)	N/A
			N/A	Flare Traversable RT?	N/A
			N/A	DWS Provided?	N/A
			N/A	DWS Contrast?	N/A
			N/A	DWS Length (in)	N/A
			N/A	DWS Full Width?	N/A
			N/A	DWS Offset (in)	N/A
			N/A	Shared Landing?	N/A
			N/A	Gutter Ponding?	N/A
			N/A	Gutter Lip Ht (in)	N/A
			N/A	Painted X Walk1?	No
				X Walk 1 Direction	To N
			N/A	X Walk 1 Width (in)	N/A
				X Walk 1 Slope (%)	1.8
				X Walk 1 X Slope (%)	1.9

N/A	Ramp inside XWalk1?	N/A
				Road Slope (%)	1.9
				Road X Slope (%)	1.8
			N/A	Any Obstructions?	N/A
<p>Total Cost:</p> <p>\$ 1850.00</p>				Obstruction Type	
			N/A		
			N/A		
			Yes	Surface Condition? (G/P)	Good
