# Access Compliance Report

## Public Rights-of-Way

| Intersection ID: 44486 | Main Street: NEWFIELD_ST | Cross Street: DARWICK_ST | Location: SE |
| ADA ID: FDC3EE514DBC | Ramp Type: PerpDiag | Initial Pass/Fail: Fail | Overall Compliance: No |

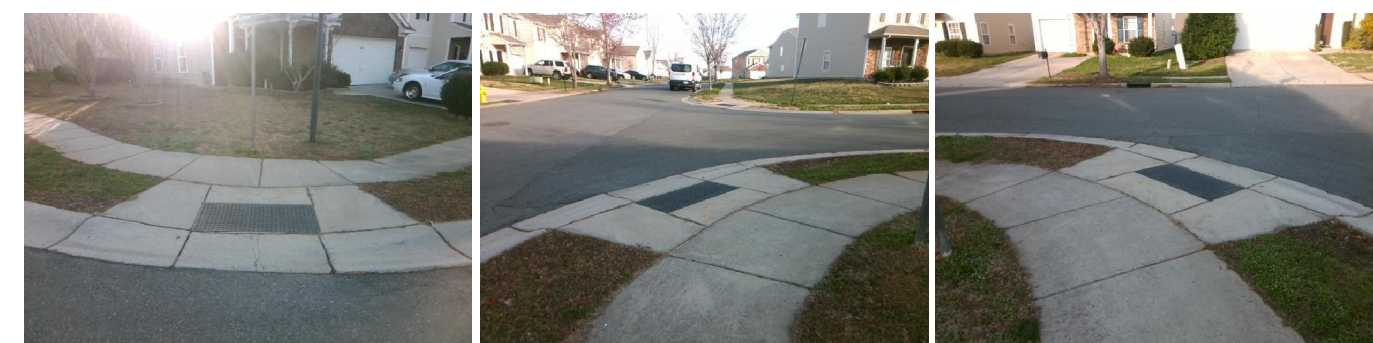
**Not Found, R304.5.1**

| Compliance | Description | Data | Compliance | Description | Data |
|---|---|---|---|---|---|
| No | Ramp Width (in) | 47.5 | Yes | Ramp XSlope (%) | 1.2 |

**Remove & Replace Curb Ramp With Two New Directional Ramps or Equivalent.**
