Access Compliance Report

Public Rights-of-Way

(Curb Ramps)

| Intersection ID: 8573 | Main Street: N_GRAHAM_ST | Cross Street: ATANDO_AV | Location: SE |

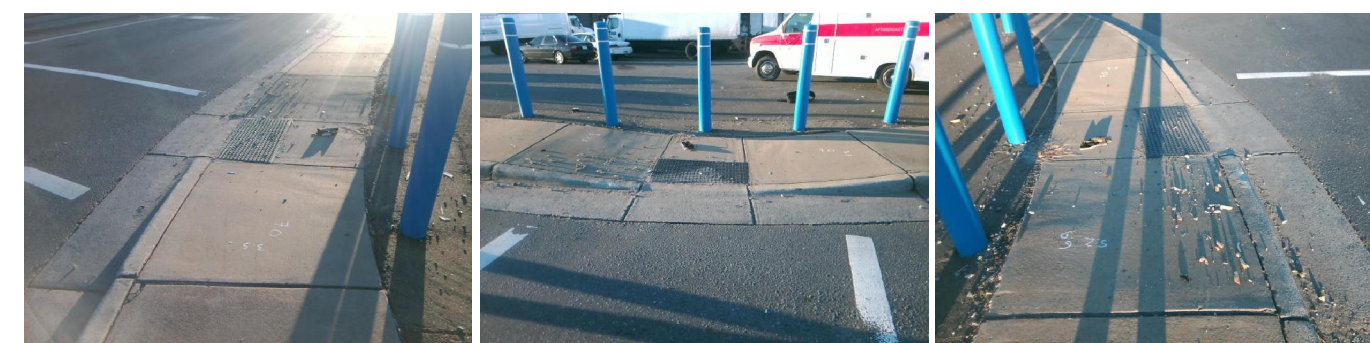
| Compliance | Description | Data | Compliance | Description | Data |
|---|---|---|---|---|---|
| No | Ramp XSlope LT (%) | 5.2 | No | Ramp XSlope RT (%) | 3.5 |

Remove & Replace Entire Ramp.
