Access Compliance Report

Public Rights-of-Way

(Curb Ramps)

Intersection ID: 11878	Main Street: MIMOSA_AV	Cross Street: THE_PLAZA	Location: SW
ADA ID: FDFD9A9ED327	Ramp Type: Perp	Initial Pass/Fail: Fail	Overall Compliance: No
		Severity Score: 1.25

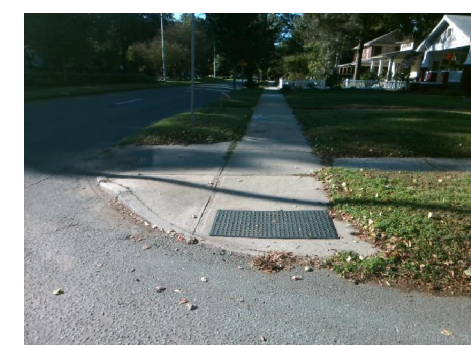
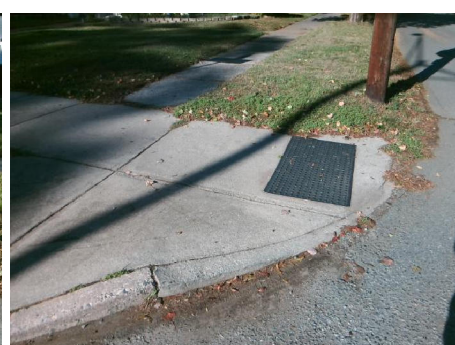
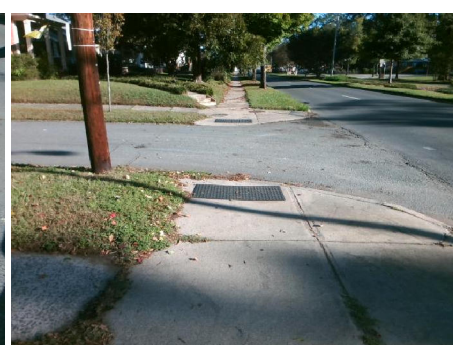
Possible Solutions:		Compliance	Description	Data
	Remove & Replace Entire Ramp.		N/A	Ramp Length (in)	72.0
			Yes	Ramp Width (in)	56.0
			N/A	Flare Type LT	N/A
			N/A	Flare Slope LT (%)	N/A
			N/A	Flare Traversable LT?	N/A
			N/A	Landing Length (in)	N/A
			N/A	Landing Width (in)	N/A
			N/A	Landing Slope (%)	N/A
			N/A	Landing X Slope (%)	N/A
<p>Surveyor Notes:</p> <p>N/A</p> <p>PROW/ADA:</p> <p>Not Found, R304.5.3</p>			N/A	Flare Type RT	N/A
			N/A	Flare Slope RT (%)	N/A
			N/A	Flare Traversable RT?	N/A
			N/A	DWS Provided?	N/A
			N/A	DWS Contrast?	N/A
			N/A	DWS Length (in)	N/A
			N/A	DWS Full Width?	N/A
			N/A	DWS Offset (in)	N/A
			N/A	Shared Landing?	N/A
			N/A	Gutter Ponding?	N/A
			N/A	Gutter Lip Ht (in)	N/A
			N/A	Painted X Walk1?	No
				X Walk 1 Direction	To N
			N/A	X Walk 1 Width (in)	N/A
				X Walk 1 Slope (%)	1.7
				X Walk 1 X Slope (%)	1.9

N/A	Ramp inside XWalk1?	N/A
				Road Slope (%)	N/A
				Road X Slope (%)	N/A
			N/A	Any Obstructions?	N/A
Total Cost:		\$ 1850.00		Obstruction Type	
			N/A		N/A
			Yes	Surface Condition? (G/P)	Good
