Access Compliance Report

Public Rights-of-Way

(Curb Ramps)

Intersection ID: 43581	Main Street: LUKES_DR	Cross Street: LINDA_VISTA_LN	Location:	N
ADA ID: FEFE7B3AFADD	Ramp Type: PerpDiag	Initial Pass/Fail: Fail	Overall Compliance: No	Severity Score: 35

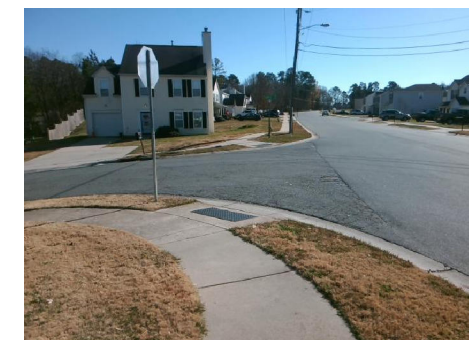
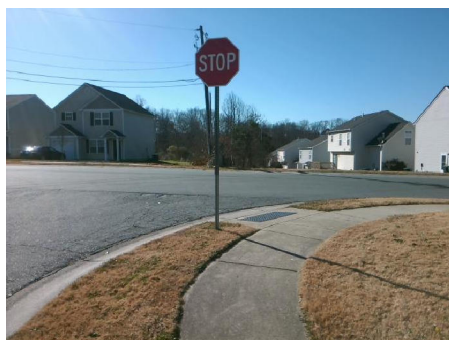
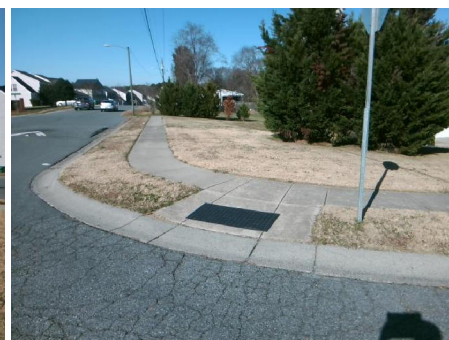
Not Found, R304.5.1

Compliance	Description	Data	Compliance	Description	Data
N/A	Ramp Length (in)	94.5	Yes	Ramp Slope (%)	8.2
No	Ramp Width (in)	30.5	Yes	Ramp XSlope (%)	1.3
N/A	Flare Type LT	N/A	N/A	Flare Type RT	N/A
N/A	Flare Slope LT (%)	N/A	N/A	Flare Slope RT (%)	N/A
N/A	Flare Traversable LT?	N/A	N/A	Flare Traversable RT?	N/A
N/A	Landing Length (in)	N/A	N/A	DWS Provided?	N/A
N/A	Landing Width (in)	N/A	N/A	DWS Contrast?	N/A
N/A	Landing Slope (%)	N/A	N/A	DWS Length (in)	N/A
N/A	Landing X Slope (%)	N/A	N/A	DWS Full Width?	N/A
N/A	Landing Curb? (Y/N)	N/A	N/A	DWS Offset (in)	N/A
N/A	Shared Landing?	N/A			
N/A	Gutter Ponding?	N/A	N/A	Gutter Slope (%)	N/A
N/A	Gutter Lip Ht (in)	N/A	N/A	Gutter X Slope (%)	N/A
N/A	Painted X Walk1?	No	N/A	Painted X Walk2?	No
	X Walk 1 Direction	To SW		X Walk 2 Direction	To SE
N/A	X Walk 1 Width (in)	N/A	N/A	X Walk 2 Width (in)	N/A
	X Walk 1 Slope (%)	8.3		X Walk 2 Slope (%)	2.6
	X Walk 1 X Slope (%)	2.0		X Walk 2 X Slope (%)	2.5

N/A	Ramp inside XWalk1?	N/A	N/A	Ramp inside XWalk2?	N/A
	Road Slope (%)	1.8	N/A	Clear Space?	N/A
	Road X Slope (%)	4.0	N/A	Clear Space to XWalk (in)	N/A
N/A	Any Obstructions?	N/A	N/A	Storm Grate/Utility Hazard?	N/A
	Obstruction Type			Storm Grate/Utility Type	
		N/A			N/A
			Yes	Surface Condition? (G/P)	Good

Remove & Replace Curb Ramp With Two New Directional Ramps or Equivalent.
