Access Compliance Report

Public Rights-of-Way

(Curb Ramps)

Intersection ID: 14690	Main Street: LINGANORE_PL	Cross Street: ROMANY_RD	Location: NW
ADA ID: FFF5CD4A77DC	Ramp Type: PerpDiag	Initial Pass/Fail: Fail	Overall Compliance: No
			Severity Score: 13.75

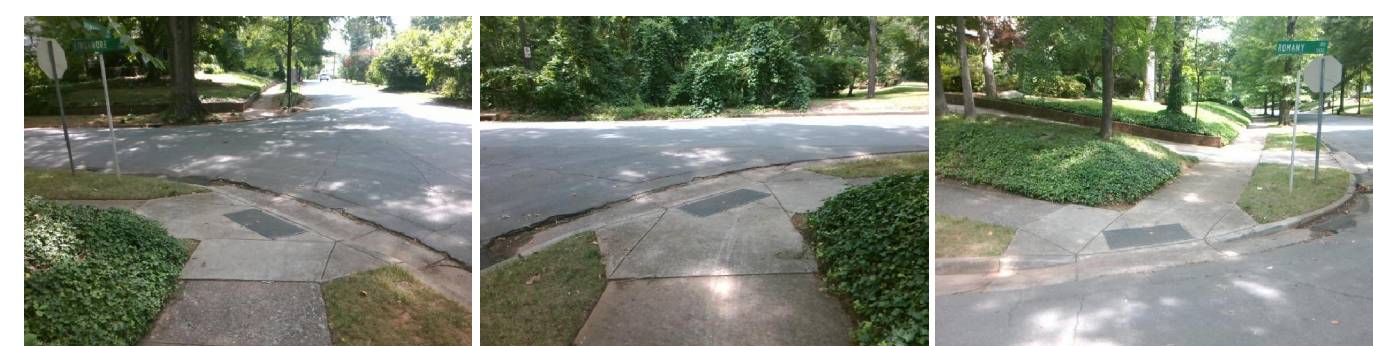
N/A	DWS Provided?	N/A
			N/A	DWS Contrast?	N/A
			N/A	DWS Length (in)	N/A
			N/A	DWS Full Width?	N/A
			N/A	DWS Offset (in)	N/A
			N/A	Gutter Slope (%)	N/A
			N/A	Gutter X Slope (%)	N/A
			N/A	Painted X Walk2?	No
				X Walk 2 Direction	To E
			N/A	X Walk 2 Width (in)	N/A
				X Walk 2 Slope (%)	2.2
				X Walk 2 X Slope (%)	3.9
			N/A	Ramp inside XWalk2?	N/A
			N/A	Clear Space?	N/A
			N/A	Clear Space to XWalk (in)	N/A
			N/A	Storm Grate/Utility Hazard?	N/A
				Storm Grate/Utility Type	
<p>Total Cost:</p> <p>\$ 3200.00</p>			N/A		N/A
			Yes	Surface Condition? (G/P)	Good

Possible Solutions:		Compliance	Description	Data
	Remove & Replace Curb Ramp With Two New Directional Ramps or Equivalent.		Compliance	Description	Data
			N/A	Ramp Length (in)	59.0
			Yes	Ramp Width (in)	70.0
			N/A	Flare Type LT	N/A
			N/A	Flare Slope LT (%)	N/A
			N/A	Flare Traversable LT?	N/A
			N/A	Landing Length (in)	N/A
			N/A	Landing Width (in)	N/A
			N/A	Landing Slope (%)	N/A
			N/A	Landing X Slope (%)	N/A
			N/A	Landing Curb? (Y/N)	N/A
			N/A	Shared Landing?	N/A
			N/A	Gutter Ponding?	N/A
			N/A	Gutter Lip Ht (in)	N/A
			N/A	Painted X Walk1?	No
				X Walk 1 Direction	To S
			N/A	X Walk 1 Width (in)	N/A
				X Walk 1 Slope (%)	2.1
				X Walk 1 X Slope (%)	0.2
<p>Surveyor Notes:</p> <p>N/A</p> <p>PROW/ADA:</p> <p>Not Found, R304.2.2, R304.5.3</p>			N/A	Flare Type RT	N/A
			N/A	Flare Slope RT (%)	N/A
			N/A	Flare Traversable RT?	N/A
