Access Compliance Report

Public Rights-of-Way

(Island Curb Cuts)

Intersection ID: 27806	Main Street: PARKS_FARM_LN	Cross Street: REA_RD	Location: E
ADA ID: 028D93630243	Curb Cut Type: MedianRefuge2	Initial Pass/Fail: Fail	Overall Compliance: No
Codes/Mitigation Info/Possible Solution		Field Measurements/Component Compliance	
Severity Score: 8.75

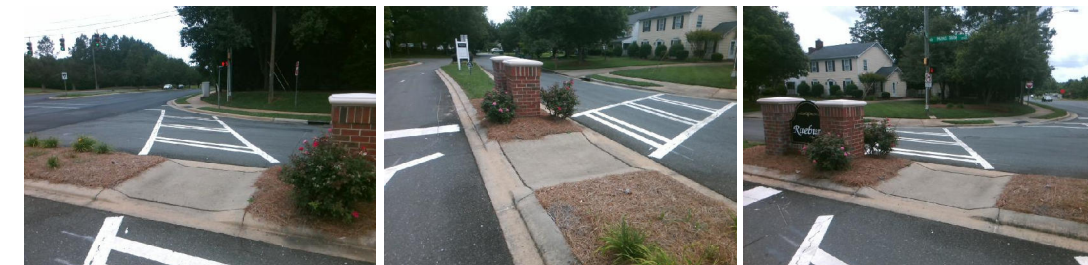
Compliance	Description	Data	Compliance	Description	Data
No	Refuge 1 Length (In)	34.0	N/A	Gutter 1 Ponding?	N/A
No	Refuge 1 Width (In)	54.0	N/A	Gutter 1 Lip Ht (In)	N/A
Yes	Refuge 1 Slope (%)	1.6	N/A	Gutter 1 Slope (%)	N/A
Yes	Refuge 1 X Slope (%)	1.1	N/A	Gutter 1 X Slope (%)	N/A
N/A	Painted X Walk1?	Yes	N/A	DWS 1 Provided?	N/A
N/A	X Walk 1 Direction	To NW	N/A	DWS 1 Contrast?	N/A
N/A	X Walk 1 Width (In)	110.0	N/A	DWS 1 Length (In)	N/A
N/A	Road 1 Slope (%)	0.1	N/A	DWS 1 Full Width?	N/A
N/A	Road 1 X Slope (%)	1.2	N/A	DWS 1 Offset (In)	N/A
No	Refuge 2 Length (In)	34.0	N/A	Gutter 2 Ponding?	N/A
No	Refuge 2 Width (In)	54.0	N/A	Gutter 2 Lip Ht (In)	N/A
Yes	Refuge 2 Slope (%)	0.6	N/A	Gutter 2 Slope (%)	N/A
Yes	Refuge 2 X Slope (%)	0.2	N/A	Gutter 2 X Slope (%)	N/A
N/A	Painted X Walk2?	Yes	N/A	DWS 2 Provided?	N/A
N/A	X Walk 2 Direction	To SE	N/A	DWS 2 Contrast?	N/A
N/A	X Walk 2 Width (In)	110.0	N/A	DWS 2 Length (In)	N/A

N/A	Road 2 Slope (%)	1.1	N/A	DWS 2 Full Width?	N/A
N/A	Road 2 X Slope (%)	1.8	N/A	DWS 2 Offset (In)	N/A
N/A	Refuge 3 Length (in)	N/A	N/A	Gutter 3 Ponding?	N/A
N/A	Refuge 3 Width (in)	N/A	N/A	Gutter 3 Lip Ht (in)	N/A
N/A	Refuge 3 Slope (%)	N/A	N/A	Gutter 3 Slope (%)	N/A
N/A	Refuge 3 XSlope (%)	N/A	N/A	Gutter 3 XSlope (%)	N/A
N/A	Painted X Walk3?	N/A	N/A	DWS 3 Provided?	N/A
N/A	X Walk 3 Direction	N/A	N/A	DWS 3 Contrast?	N/A
N/A	X Walk 3 Width (in)	N/A	N/A	DWS 3 Length (in)	N/A
N/A	Road 3 Slope (%)	N/A	N/A	DWS 3 Full Width?	N/A
N/A	Road 3 XSlope (%)	N/A	N/A	DWS 3 Offset (in)	N/A
Yes	Any Obstructions?	N/A	N/A	Storm Grate/Utility Hazard?	N/A
N/A	Obstruction Type		N/A	Storm Grate/Utility Type	
		N/A			N/A
N/A	Surface Condition	Good

Possible Solutions:

Remove & Replace Entire Refuge.
