Access Compliance Report

Public Rights-of-Way

(Island Curb Cuts)

Intersection ID: 10025609	Main Street: E_WOODLAWN_RD	Cross Street: N/A	Location: S
ADA ID: 03573A8093F8	Curb Cut Type: MedianRefuge2	Initial Pass/Fail: Fail	Overall Compliance: No
Codes/Mitigation Info/Possible Solution		Field Measurements/Component Compliance

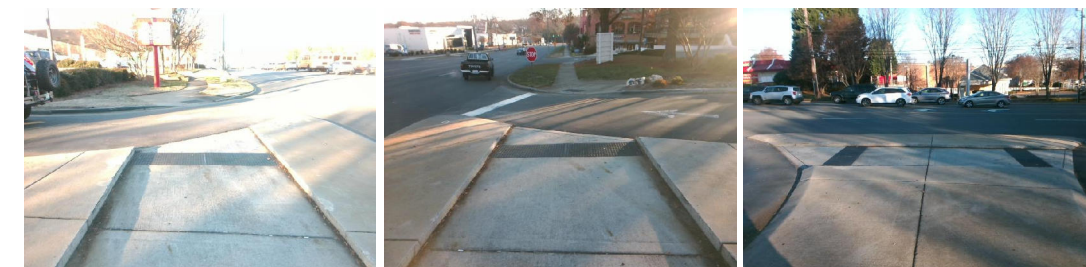
N/A	Road 2 Slope (%)	0.4	N/A	DWS 2 Full Width?	N/A
N/A	Road 2 X Slope (%)	4.6	N/A	DWS 2 Offset (In)	N/A
N/A	Refuge 3 Length (in)	N/A	N/A	Gutter 3 Ponding?	N/A
N/A	Refuge 3 Width (in)	N/A	N/A	Gutter 3 Lip Ht (in)	N/A
N/A	Refuge 3 Slope (%)	N/A	N/A	Gutter 3 Slope (%)	N/A
N/A	Refuge 3 XSlope (%)	N/A	N/A	Gutter 3 XSlope (%)	N/A
N/A	Painted X Walk3?	N/A	N/A	DWS 3 Provided?	N/A
N/A	X Walk 3 Direction	N/A	N/A	DWS 3 Contrast?	N/A
N/A	X Walk 3 Width (in)	N/A	N/A	DWS 3 Length (in)	N/A
N/A	Road 3 Slope (%)	N/A	N/A	DWS 3 Full Width?	N/A
N/A	Road 3 XSlope (%)	N/A	N/A	DWS 3 Offset (in)	N/A
Yes	Any Obstructions?	N/A	N/A	Storm Grate/Utility Hazard?	N/A
N/A	Obstruction Type		N/A	Storm Grate/Utility Type	
		N/A			N/A
N/A	Surface Condition	Good
