Access Compliance Report

Public Rights-of-Way

(Island Curb Cuts)

Intersection ID: 7375	Main Street: N_TRYON_ST	Cross Street: TOM_HUNTER_RD	Location: E
ADA ID: 03A2601F0A64	Curb Cut Type: MedianRefuge2	Initial Pass/Fail: Fail	Overall Compliance: No
Codes/Mitigation Info/Possible Solution		Field Measurements/Component Compliance	
Severity Score: 0

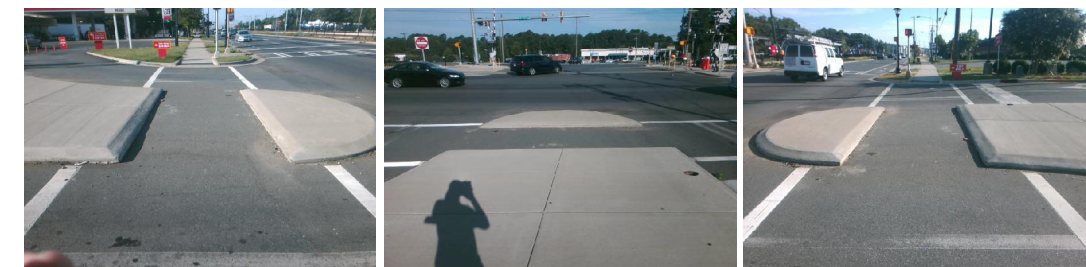
Compliance	Description	Data	Compliance	Description	Data
Yes	Refuge 1 Length (In)	90.0	N/A	Gutter 1 Ponding?	N/A
Yes	Refuge 1 Width (In)	85.0	N/A	Gutter 1 Lip Ht (In)	N/A
Yes	Refuge 1 Slope (%)	0.7	N/A	Gutter 1 Slope (%)	N/A
Yes	Refuge 1 X Slope (%)	4.4	N/A	Gutter 1 X Slope (%)	N/A
N/A	Painted X Walk1?	Yes	N/A	DWS 1 Provided?	N/A
N/A	X Walk 1 Direction	To N	N/A	DWS 1 Contrast?	N/A
N/A	X Walk 1 Width (In)	119.0	N/A	DWS 1 Length (In)	N/A
N/A	Road 1 Slope (%)	4.3	N/A	DWS 1 Full Width?	N/A
N/A	Road 1 X Slope (%)	1.3	N/A	DWS 1 Offset (In)	N/A
Yes	Refuge 2 Length (In)	90.0	N/A	Gutter 2 Ponding?	N/A
Yes	Refuge 2 Width (In)	85.0	N/A	Gutter 2 Lip Ht (In)	N/A
Yes	Refuge 2 Slope (%)	0.9	N/A	Gutter 2 Slope (%)	N/A
Yes	Refuge 2 X Slope (%)	4.0	N/A	Gutter 2 X Slope (%)	N/A
N/A	Painted X Walk2?	Yes	N/A	DWS 2 Provided?	N/A
N/A	X Walk 2 Direction	To S	N/A	DWS 2 Contrast?	N/A
N/A	X Walk 2 Width (In)	119.0	N/A	DWS 2 Length (In)	N/A

N/A	Road 2 Slope (%)	2.6	N/A	DWS 2 Full Width?	N/A
N/A	Road 2 X Slope (%)	2.5	N/A	DWS 2 Offset (In)	N/A
N/A	Refuge 3 Length (in)	N/A	N/A	Gutter 3 Ponding?	N/A
N/A	Refuge 3 Width (in)	N/A	N/A	Gutter 3 Lip Ht (in)	N/A
N/A	Refuge 3 Slope (%)	N/A	N/A	Gutter 3 Slope (%)	N/A
N/A	Refuge 3 XSlope (%)	N/A	N/A	Gutter 3 XSlope (%)	N/A
N/A	Painted X Walk3?	N/A	N/A	DWS 3 Provided?	N/A
N/A	X Walk 3 Direction	N/A	N/A	DWS 3 Contrast?	N/A
N/A	X Walk 3 Width (in)	N/A	N/A	DWS 3 Length (in)	N/A
N/A	Road 3 Slope (%)	N/A	N/A	DWS 3 Full Width?	N/A
N/A	Road 3 XSlope (%)	N/A	N/A	DWS 3 Offset (in)	N/A
Yes	Any Obstructions?	N/A	N/A	Storm Grate/Utility Hazard?	N/A
N/A	Obstruction Type		N/A	Storm Grate/Utility Type	
		N/A			N/A
N/A	Surface Condition	Good

Possible Solutions:

Remove & Replace Entire Refuge.
